THE SECRETARY  
OF THE INTERIOR'S  
**STANDARDS** FOR  
THE TREATMENT  
OF HISTORIC  
PROPERTIES  
WITH  
**GUIDELINES** FOR  
PRESERVING,  
REHABILITATING,  
RESTORING &  
RECONSTRUCTING  
HISTORIC  
BUILDINGS

Revised by Anne E. Grimmer

U.S. Department of the Interior  
National Park Service  
Technical Preservation Services  
Washington, D.C.

2017

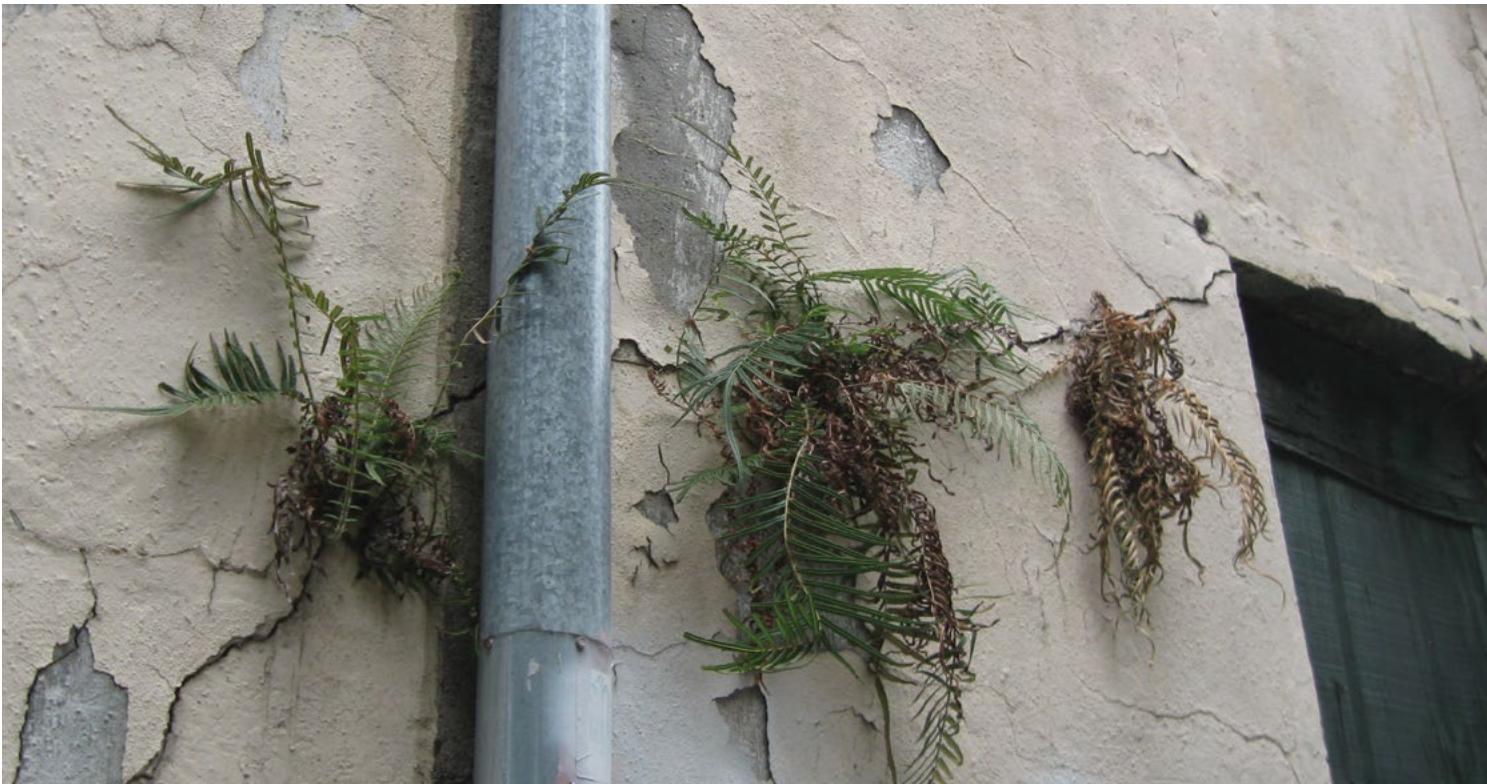
**[3] Not Recommended:**  
Cracks in the stucco have not been repaired, thereby allowing ferns to grow in the moist substrate which will cause further damage to the masonry.

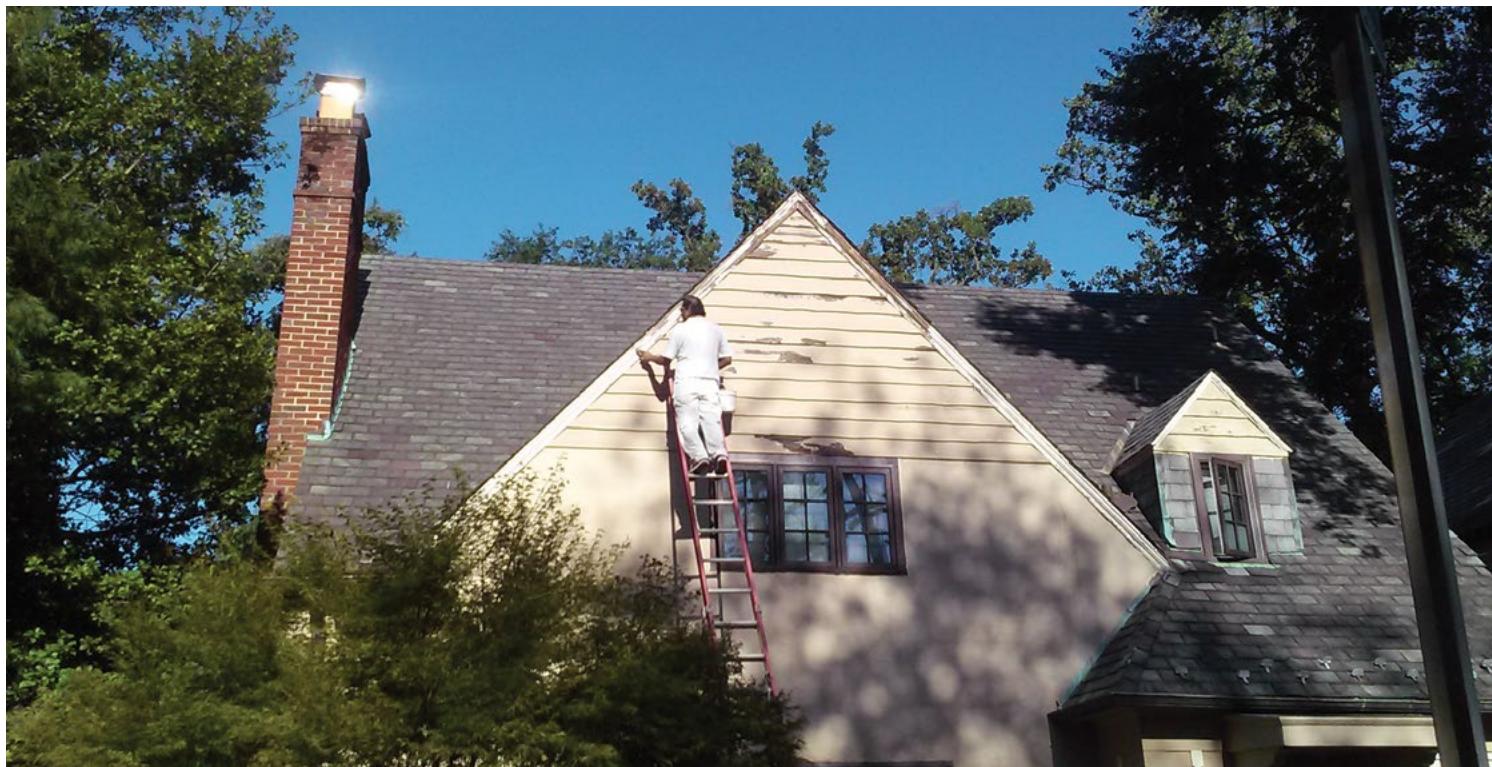
[4] Hand scraping to remove peeling paint from wood siding in preparation for repainting is an important part of regularly-scheduled maintenance.

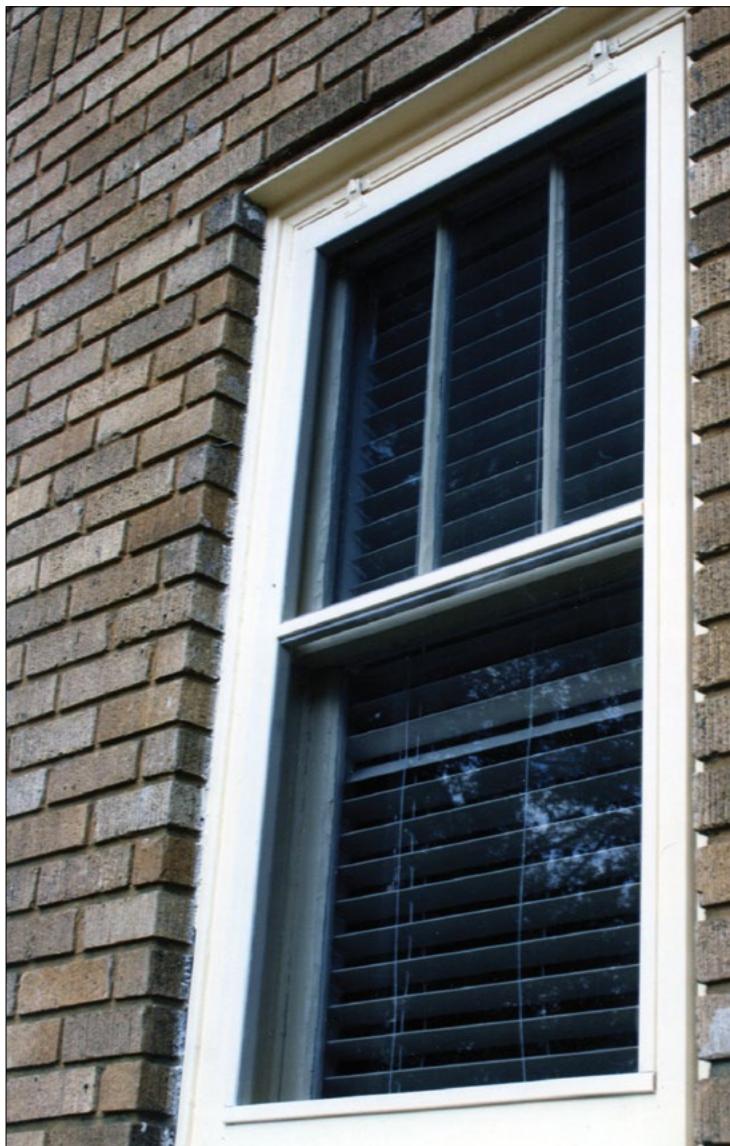
[10] Historic exterior storm windows preserve and help to insulate wood windows.

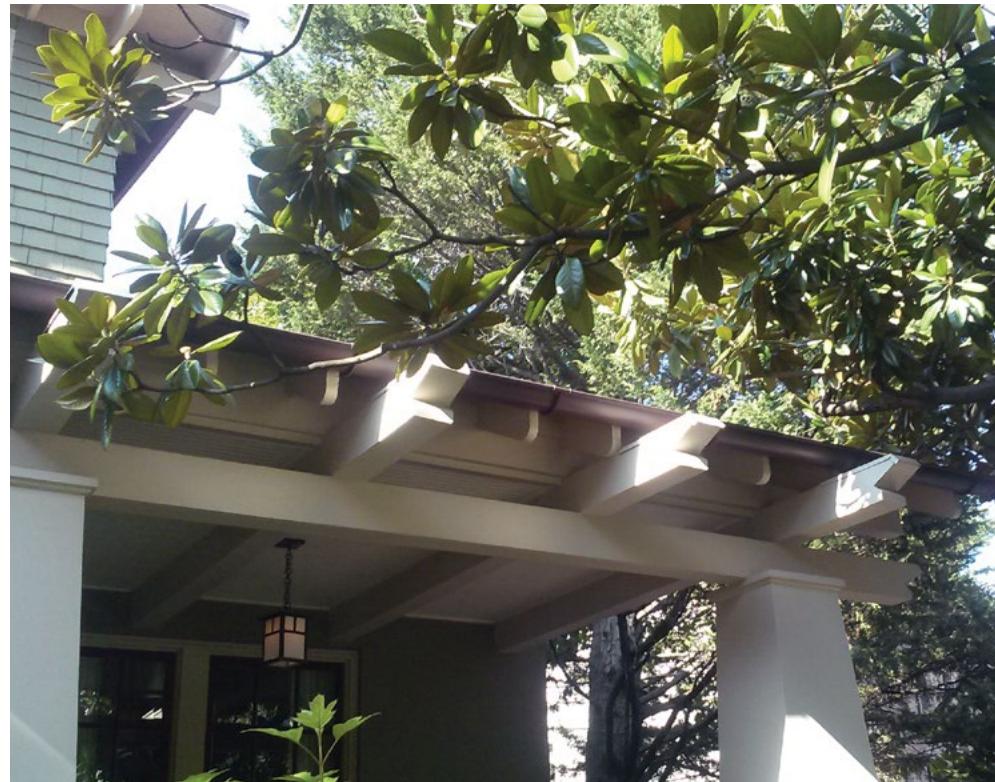
[13] It is important that exposed swallow tail porch rafters be kept painted to protect them from water damage.

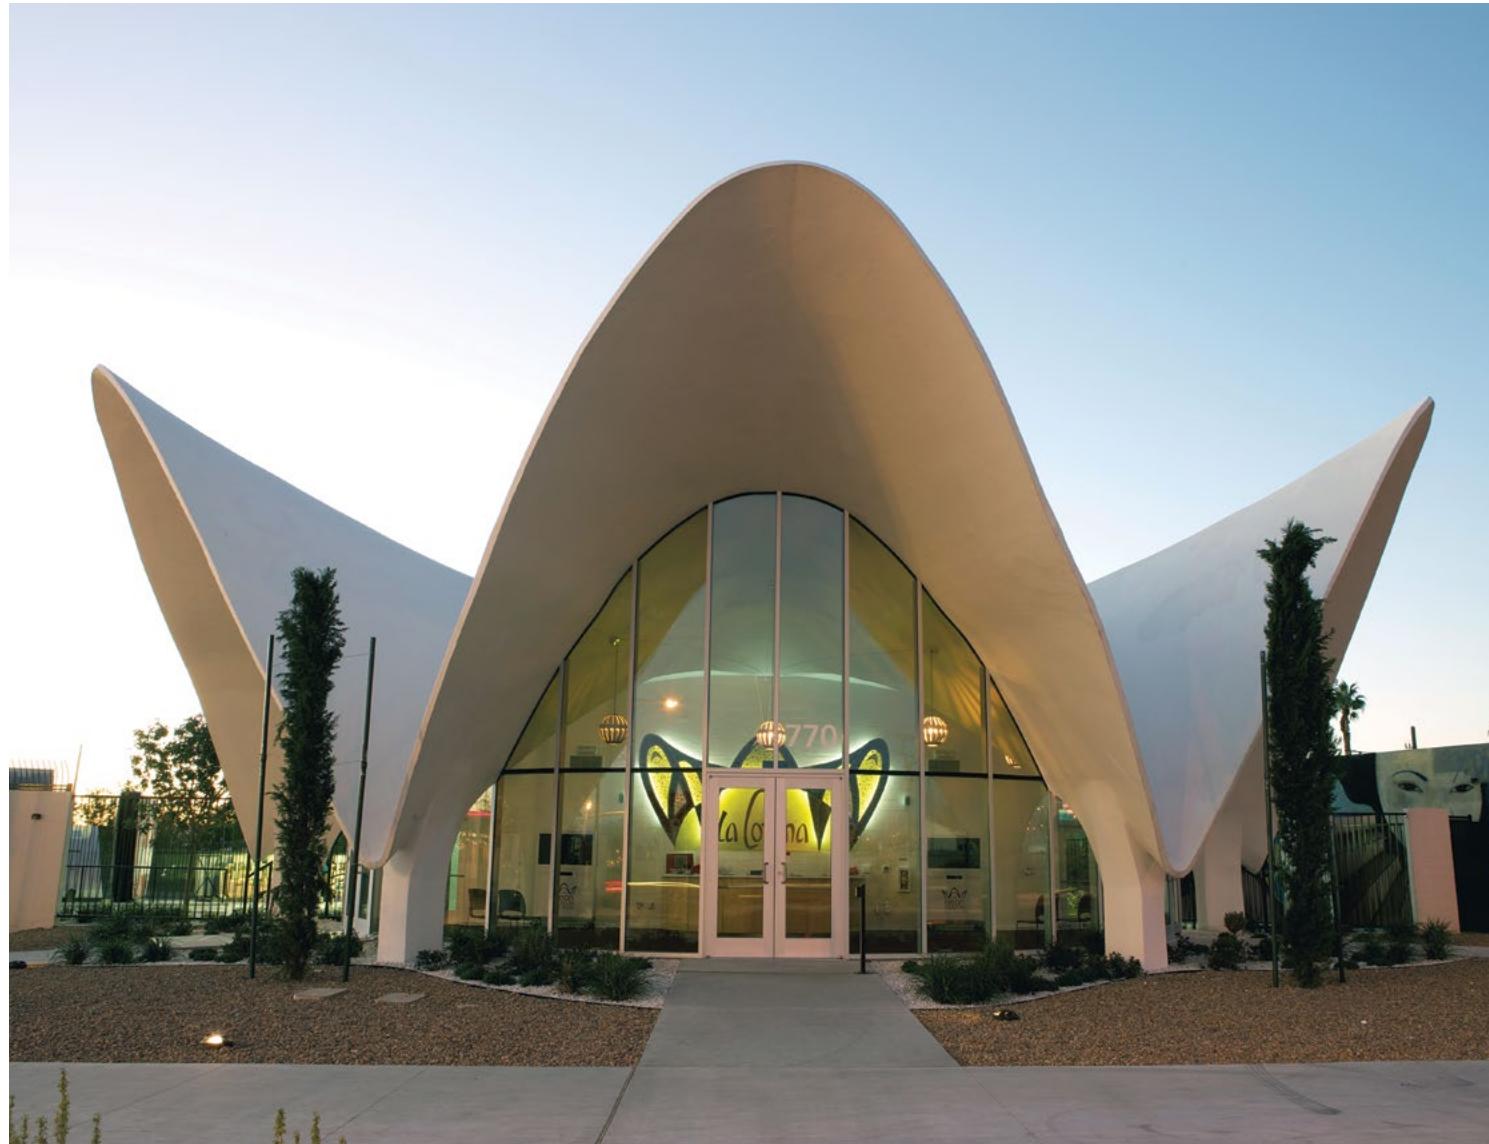
[2] Mid-century modern building technology made possible the form of this paraboloid-shaped structure and its thin concrete shell construction. Built in 1961 as the lobby of the La Concha Motel in Las Vegas, it was designed by Paul Revere Williams, one of the first prominent African-American architects. It was moved to a new location and rehabilitated to serve as the Neon Museum, and is often cited as an example of Googie architecture. Credit: Photographed with permission at The Neon Museum, Las Vegas, Nevada.

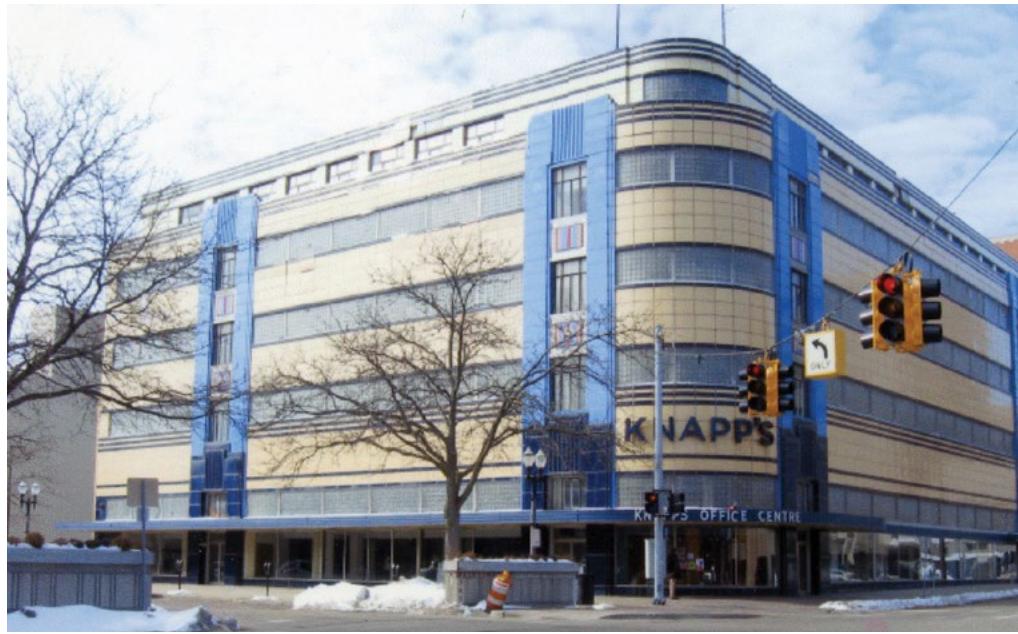
[7] (a) J.W. Knapp's Department Store, built 1937-38, in Lansing, MI, was constructed with a proprietary material named "Maul Macotta" made of enameled steel and cast-in-place concrete panels. Prior to its rehabilitation, a building inspection revealed that, due to a flaw in the original design and construction, the material was deteriorated beyond repair. The architects for the rehabilitation project devised a replacement system (b) consisting of enameled aluminum panels that matched the original colors (c). Photos and drawing (a-b): Quinn Evans Architects; Photo (c): James Haefner Photography.

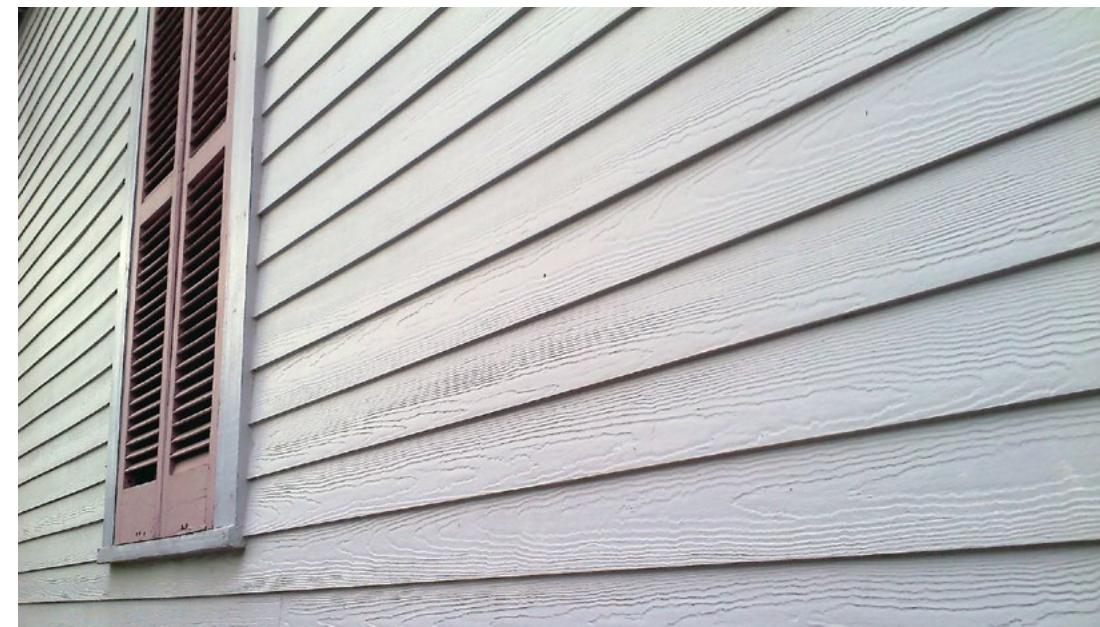
[10] **Not Recommended:** Cementitious siding with a raised wood-grain texture is not an appropriate material to replace historic wood siding, which has a smooth surface when painted.

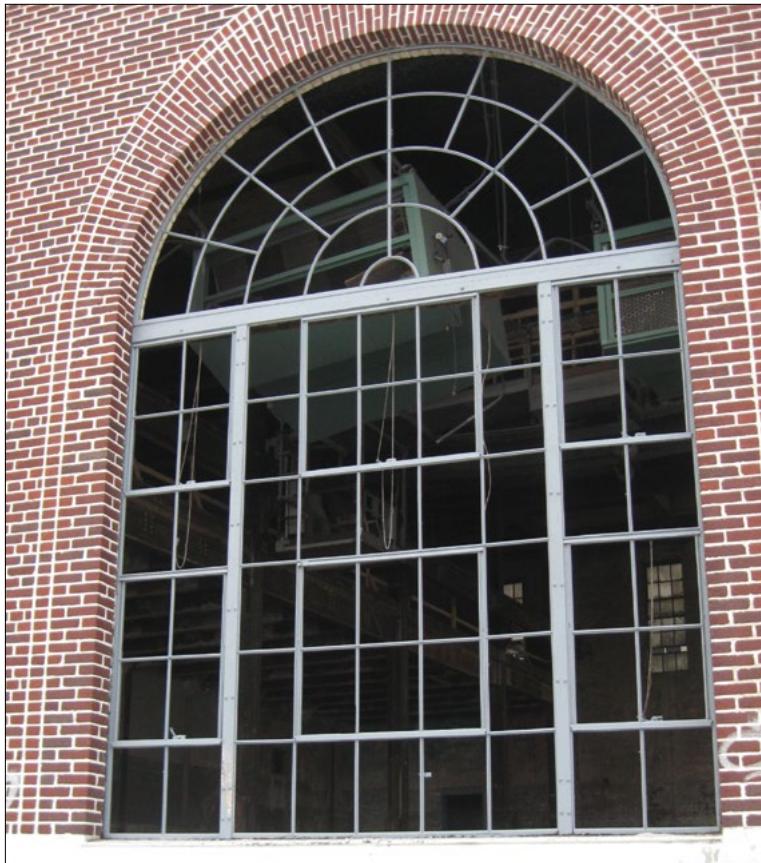
[12] This historic steel window has been cleaned, repaired, and primed in preparation for painting and reglazing.

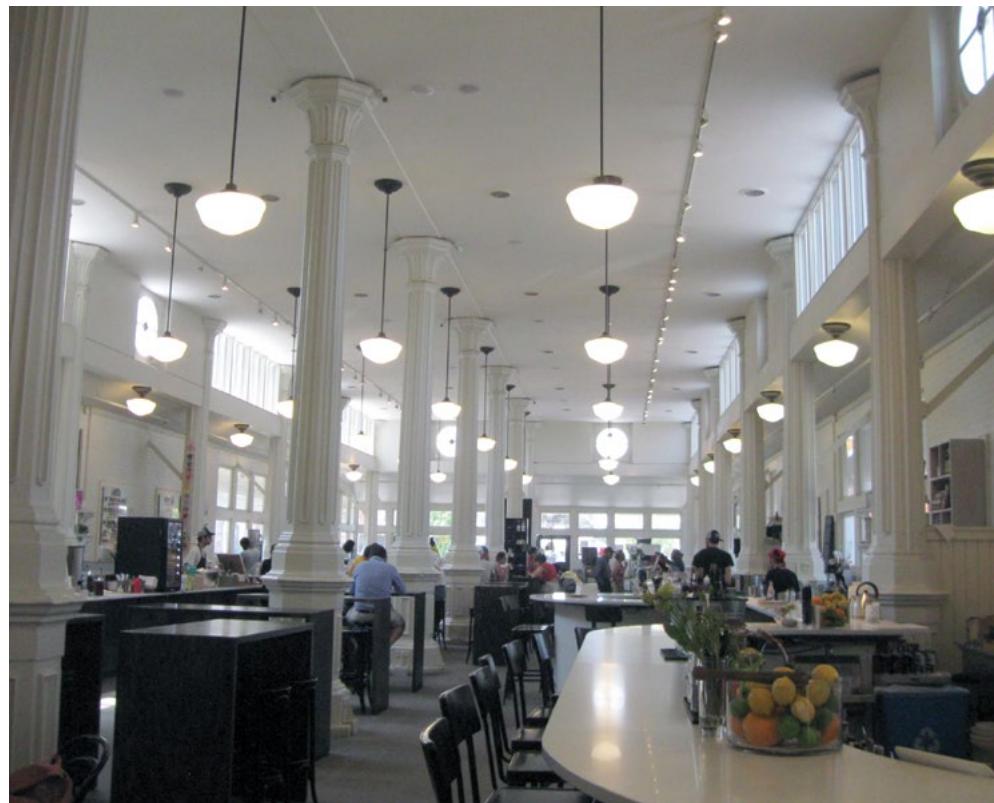
[14] Interior cast-iron columns have been cleaned and repainted as part of the rehabilitation of this historic market building for continuing use.

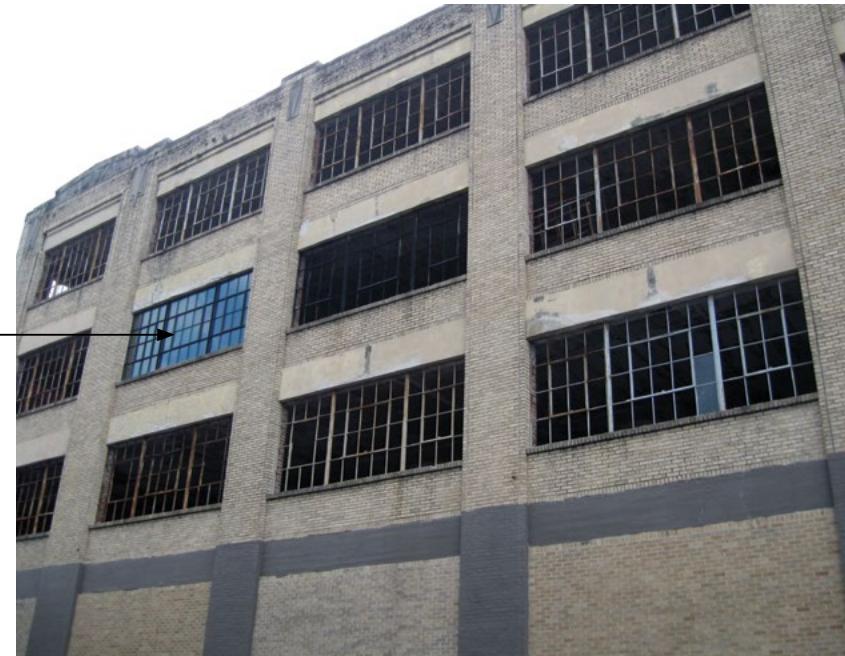
[19] Installing a mockup of a proposed replacement window can be helpful to evaluate how well the new windows will match the historic windows that are missing or too deteriorated to repair.

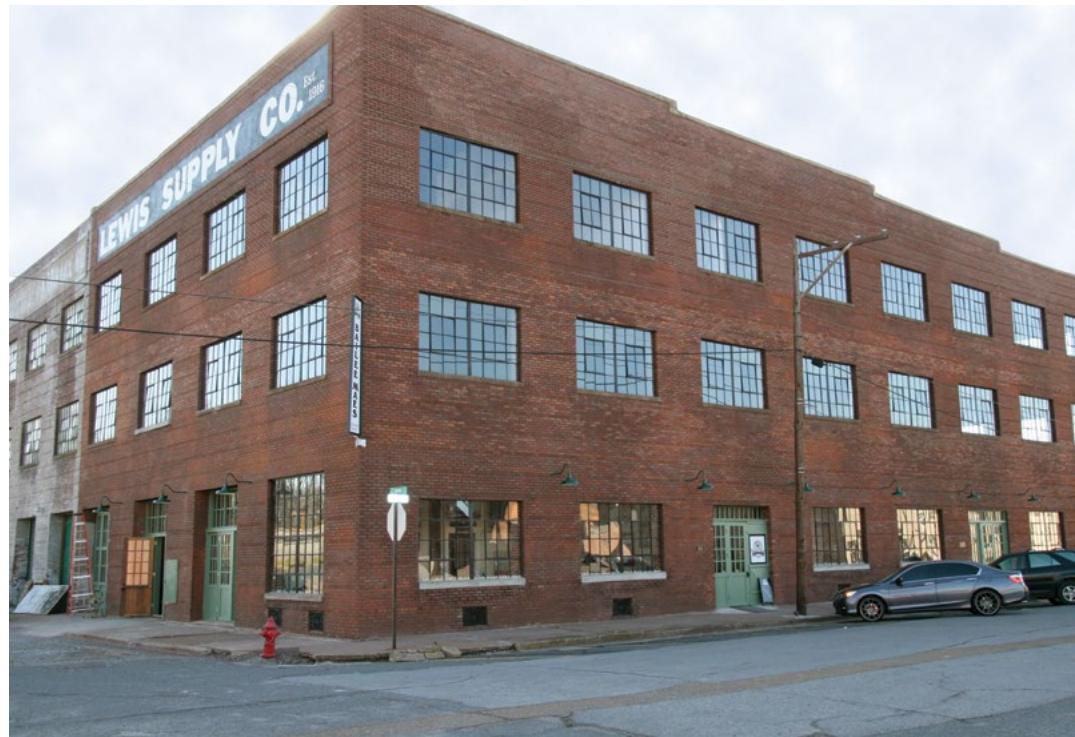
[20 a-d] The original steel windows in this industrial building were successfully repaired as part of the rehabilitation project (left).

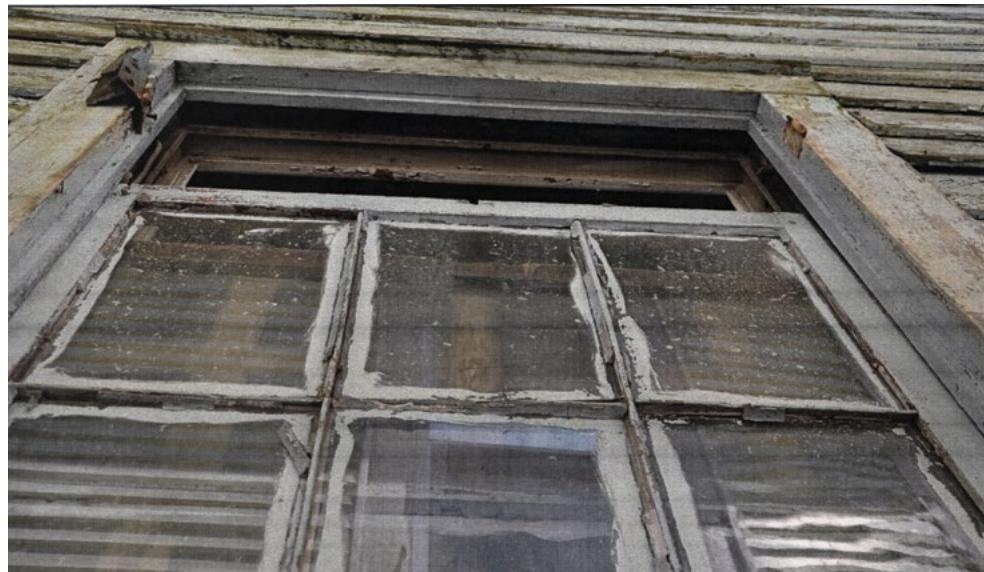
[23] (a)This deteriorated historic wood window was repaired and retained (b) in this rehabilitation project.

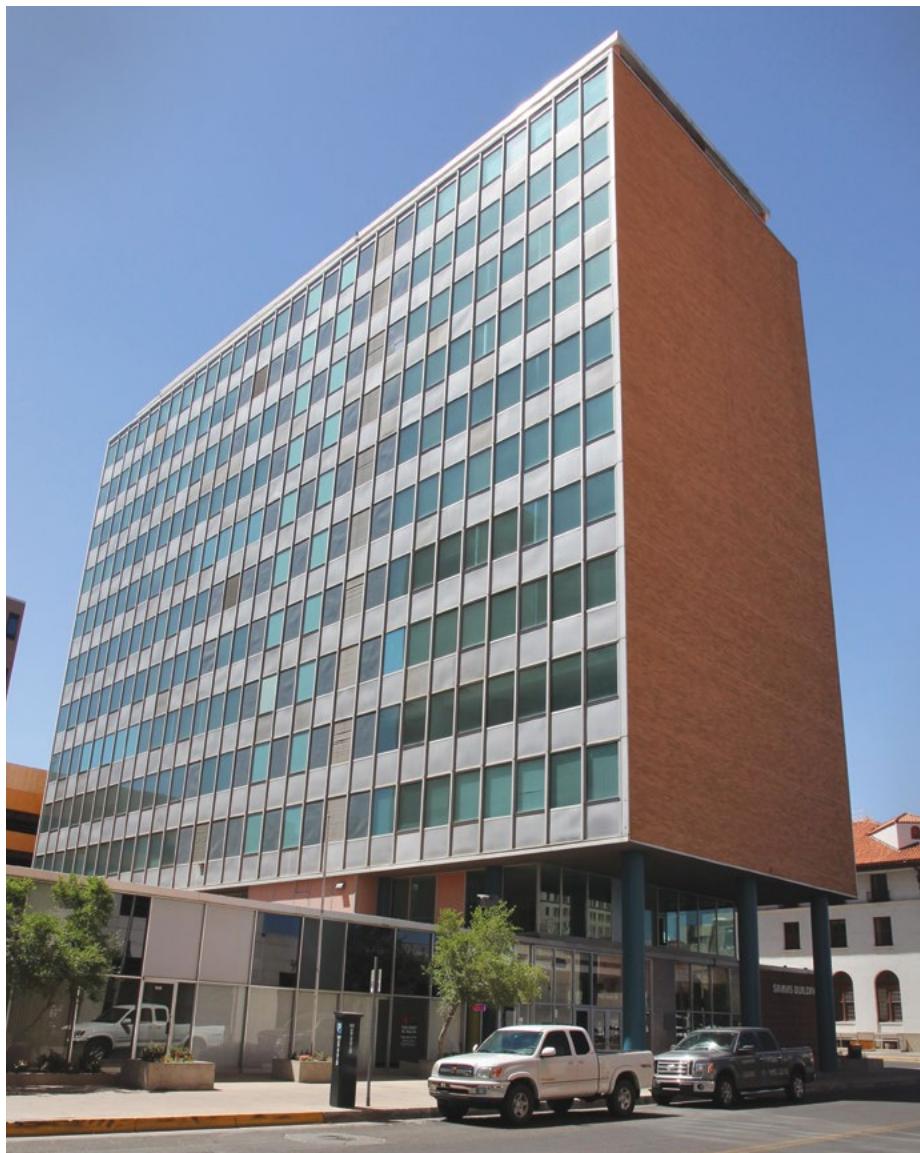
[30] Rather than replace the original curtain wall system of the 1954 Simms Building in Albuquerque, NM, with a different color tinted glass or coat it with a non-historic reflective film, the HVAC system was updated to improve energy efficiency. Photo: Harvey M. Kaplan.

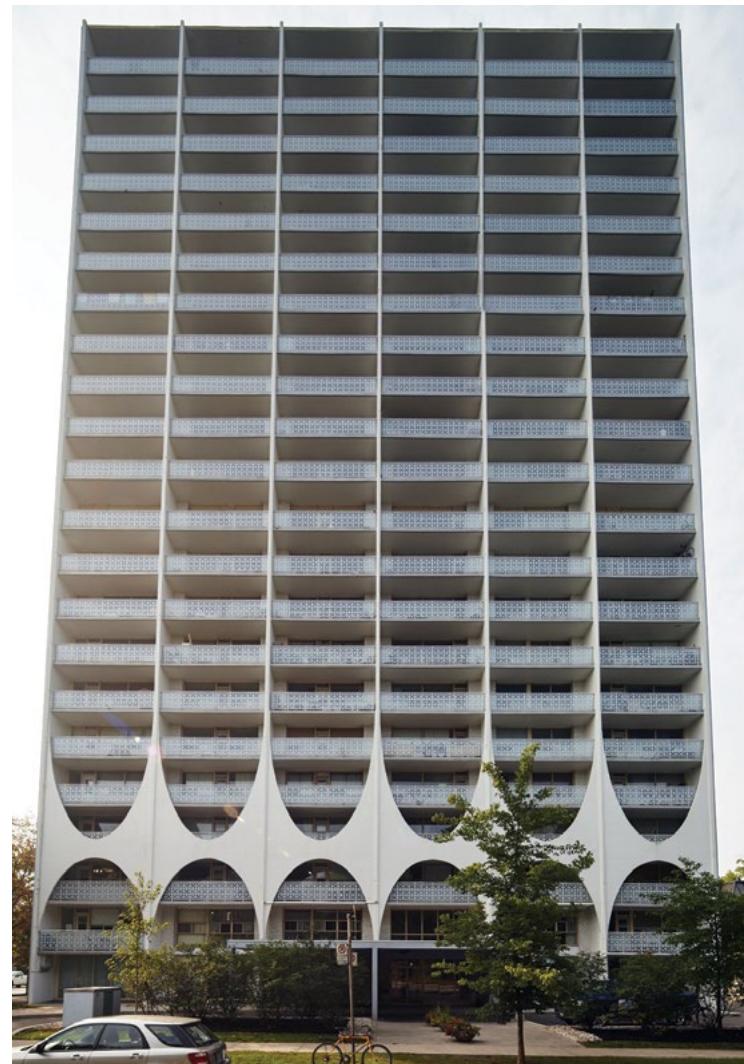
[59] (a-b) The decorative concrete balcony railings on this 1960s building did not meet life-safety code requirements. They were replaced with new glass railings with a fritted glass pattern matching the original design—a creative solution that satisfies codes, while preserving the historic appearance of the building when viewed from the street (c-d). Photos: (a, b, d) ERA Architects, Inc.; (c) Nathan Cyprys, photographer.

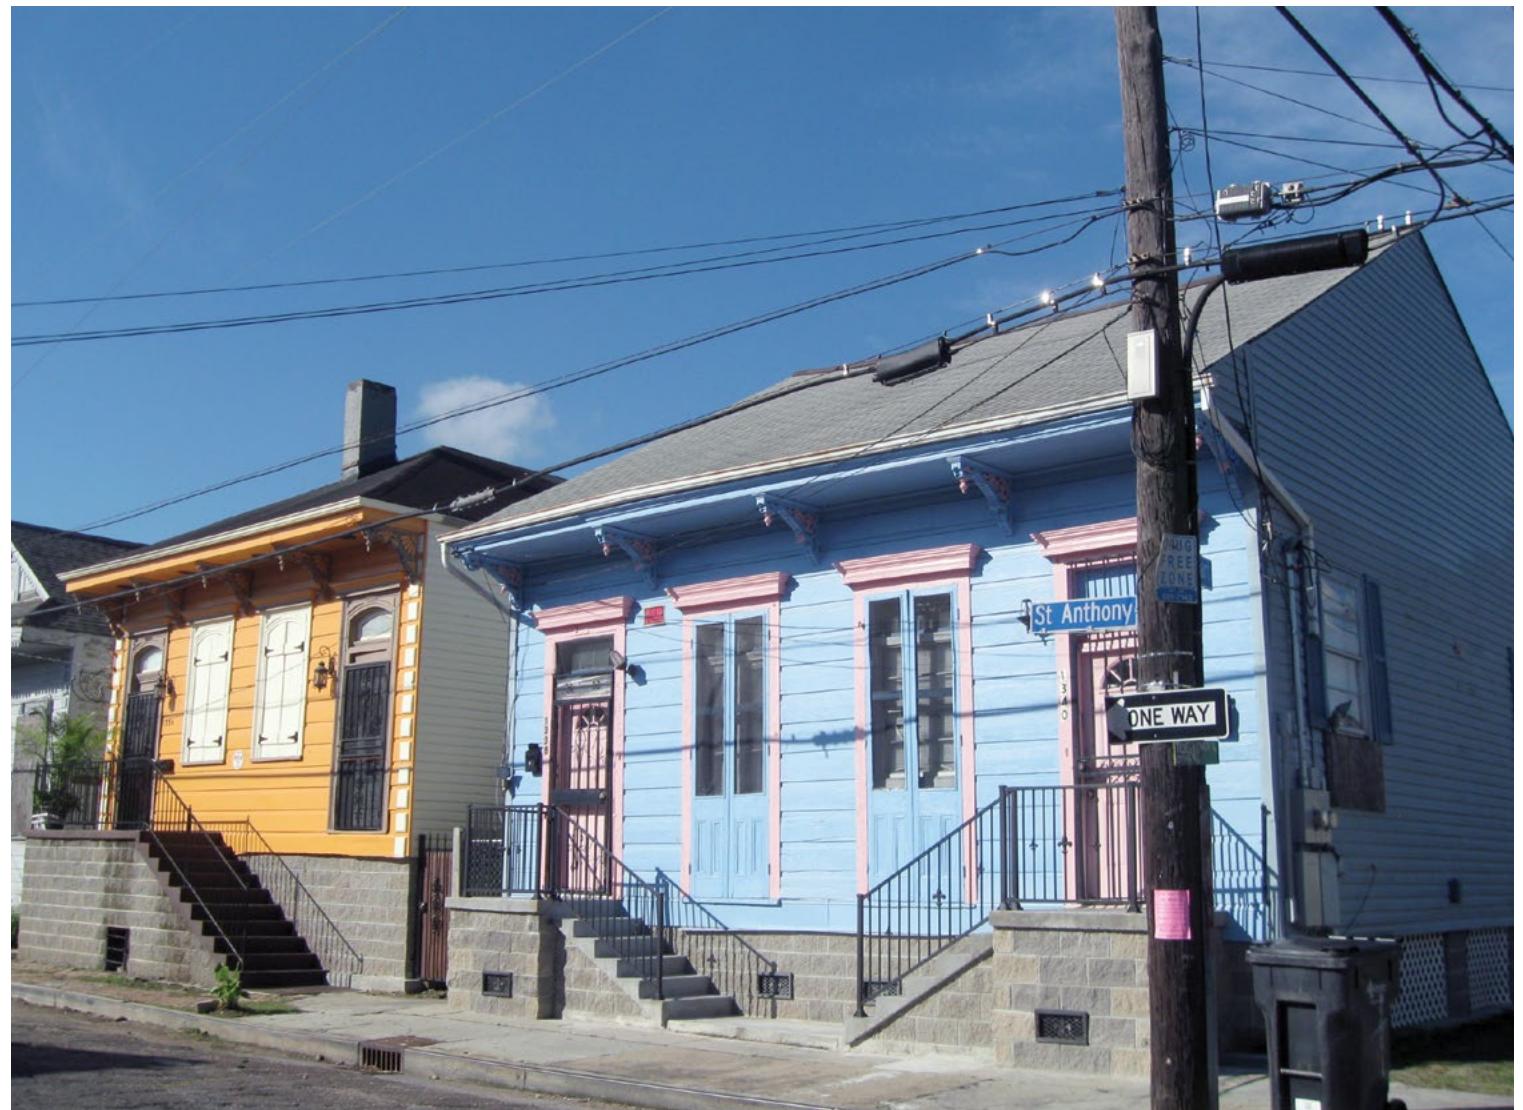
[60] In some instances, it may be necessary to elevate a historic building located in a floodplain to protect it. But this treatment is appropriate only if elevating the building will retain its historic character, including its relationship to the site, and its new height will be compatible with surrounding buildings if in a historic district. The house on the right, which has been raised only slightly, has retained its historic character. The house on the left has been raised several feet higher, resulting in a greater impact on the historic character of the house and the district.

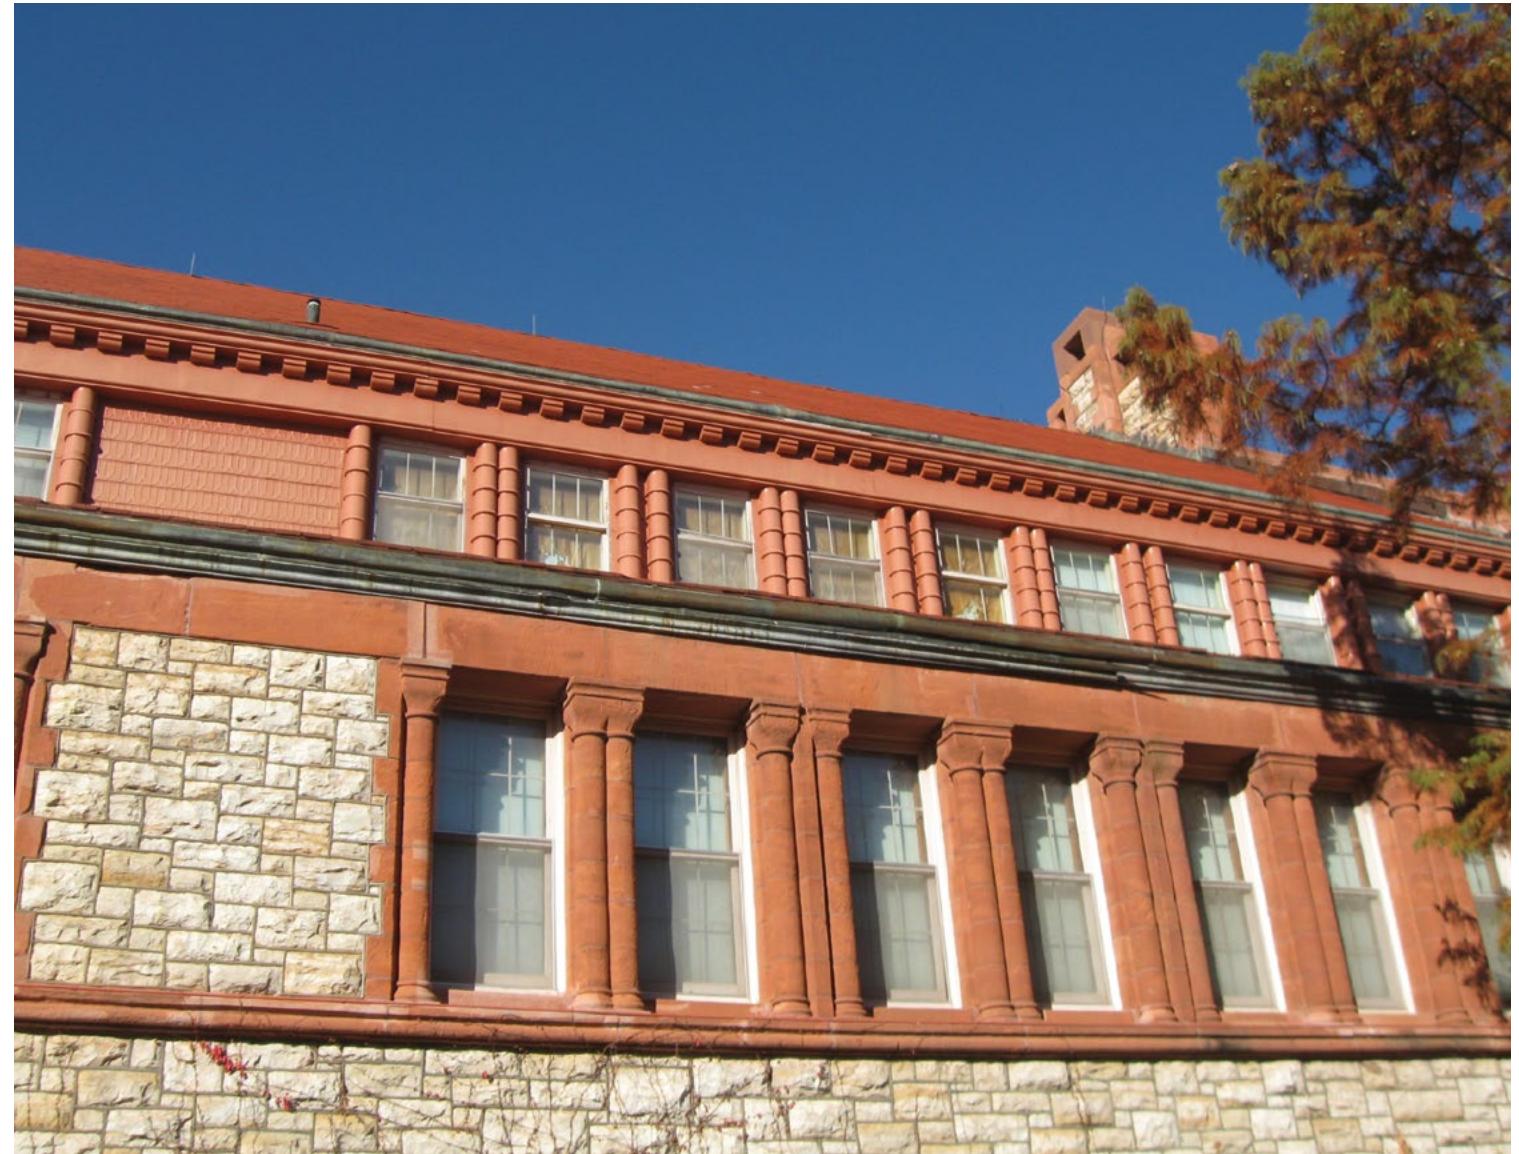
[6] Preliminary work before starting restoration revealed that the columns and the decorative shingles ornamenting the top floor of this historic building were fabricated of metal to imitate the red sandstone used elsewhere on the building.
