Jefferson Park HPOZ
COMMERCIAL STORE FRONTS

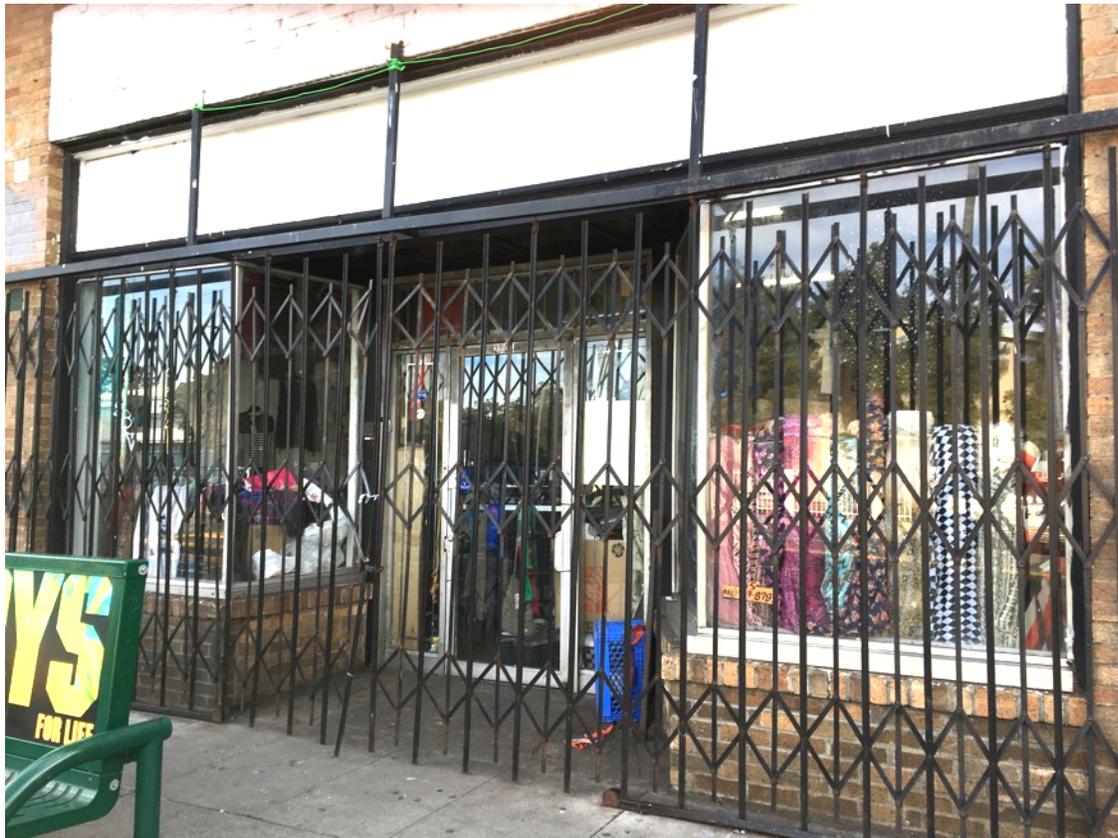
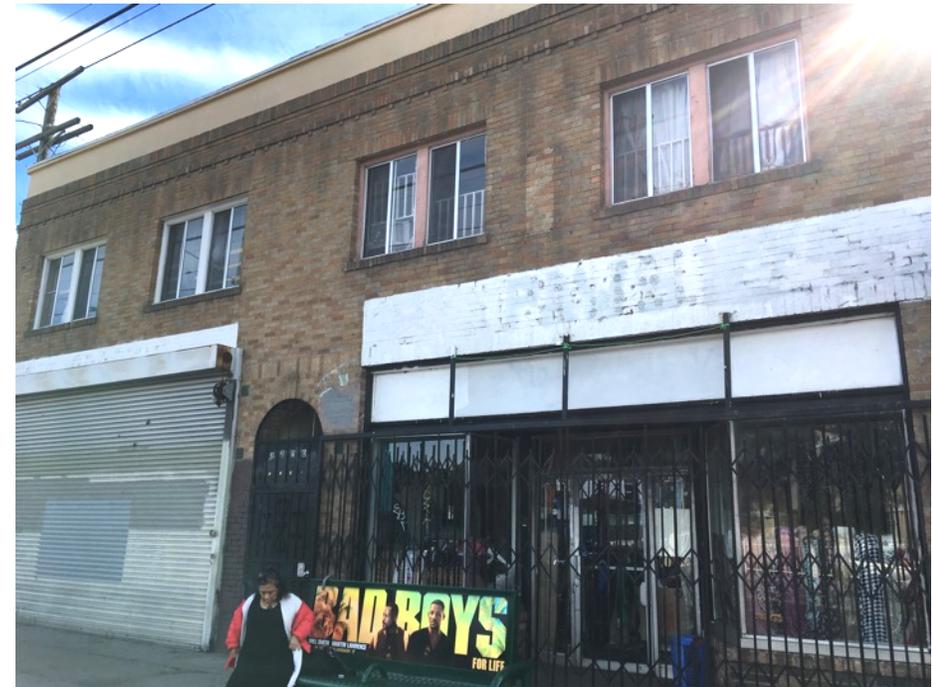
Two story commercial buildings on Jefferson Blvd.:
This is 2704 Jefferson. It shows the typical store front: inset doorway, brick bulkhead, large single pane display windows, and the multi light clerestory window has been boarded up.

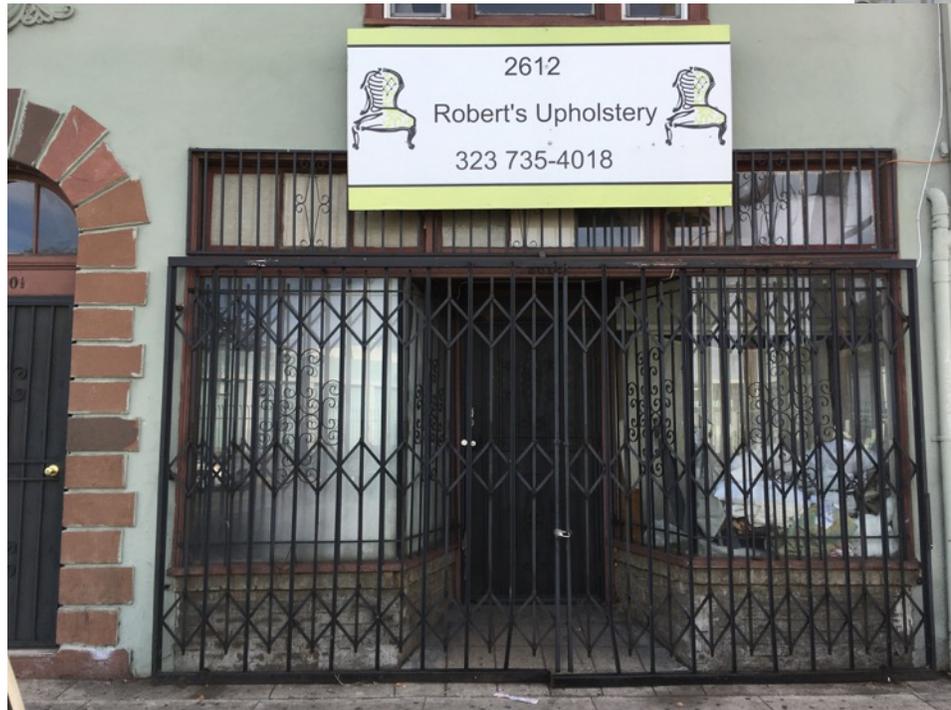
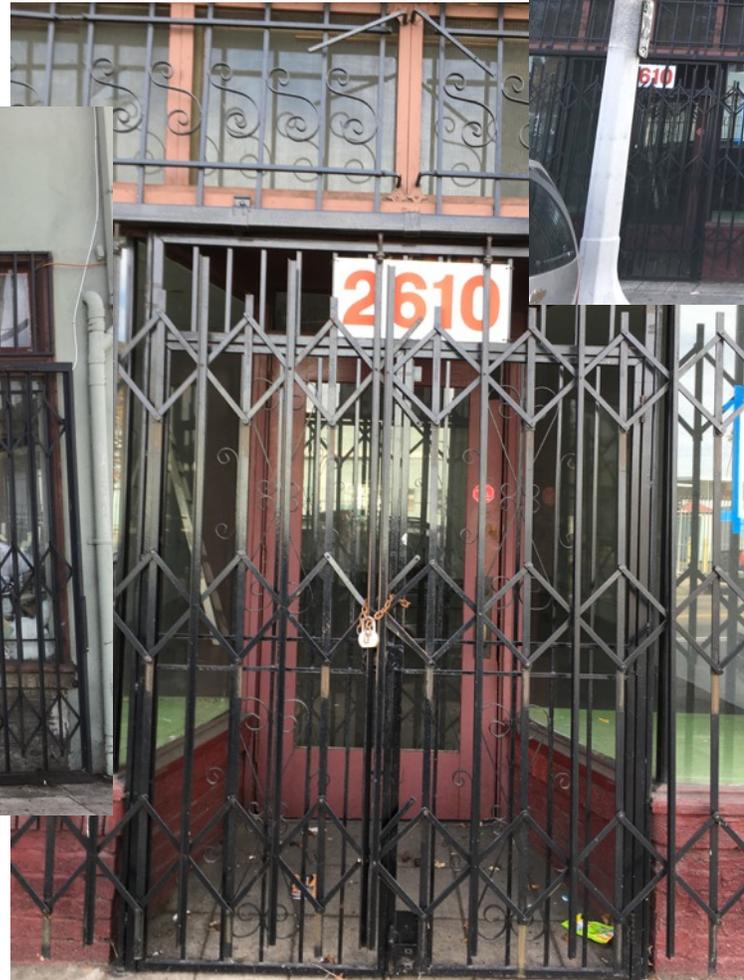
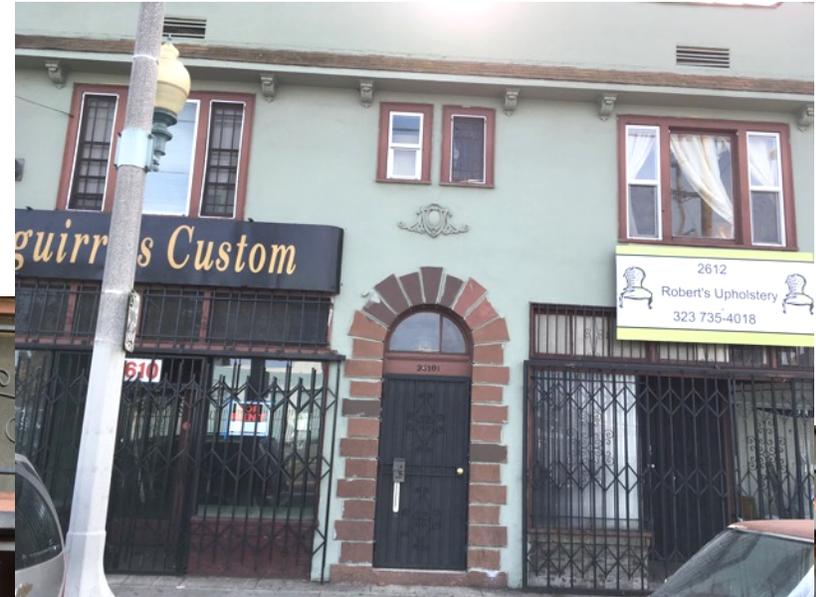
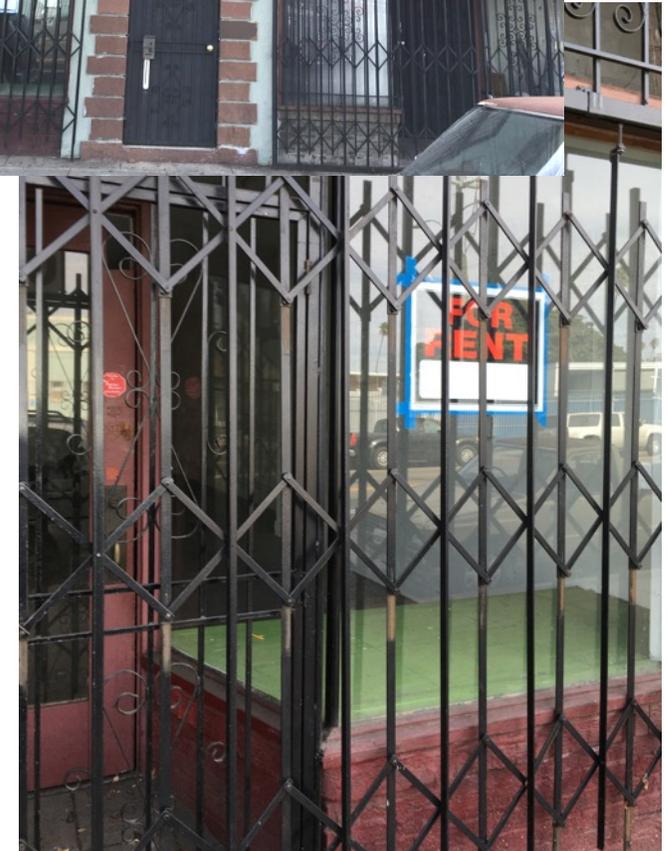
This is 2610 Jefferson Blvd. a handsome building: There are 9 lights in the clerestory. The door is original and typical – glass with a wood frame. Again, inset doorway, brick bulkhead, single pane display windows.

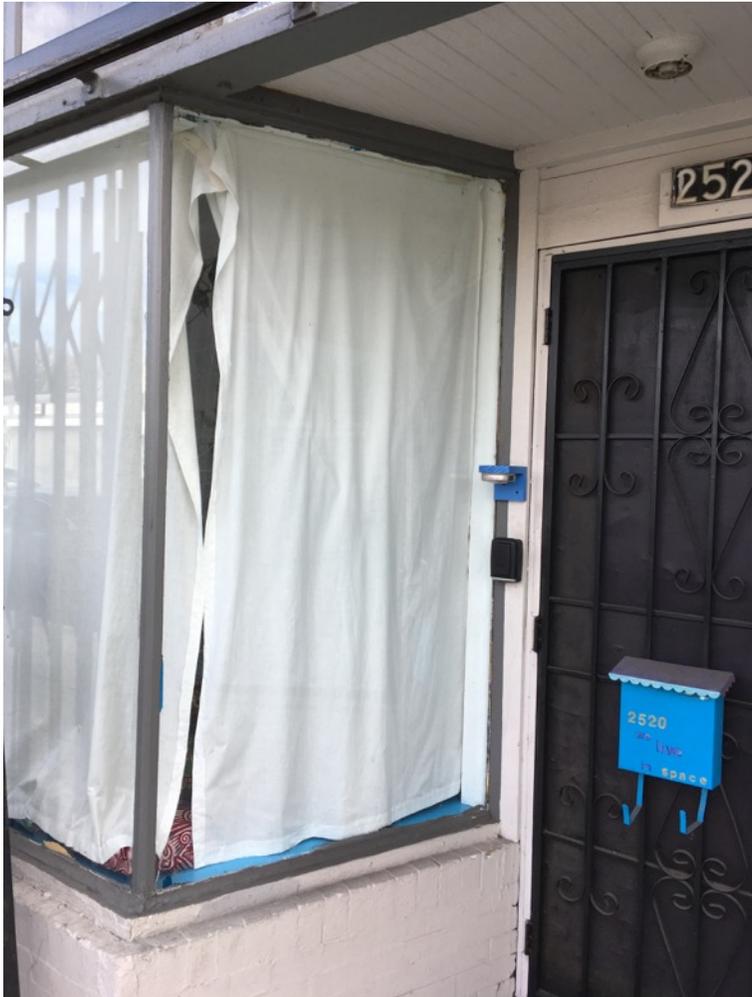
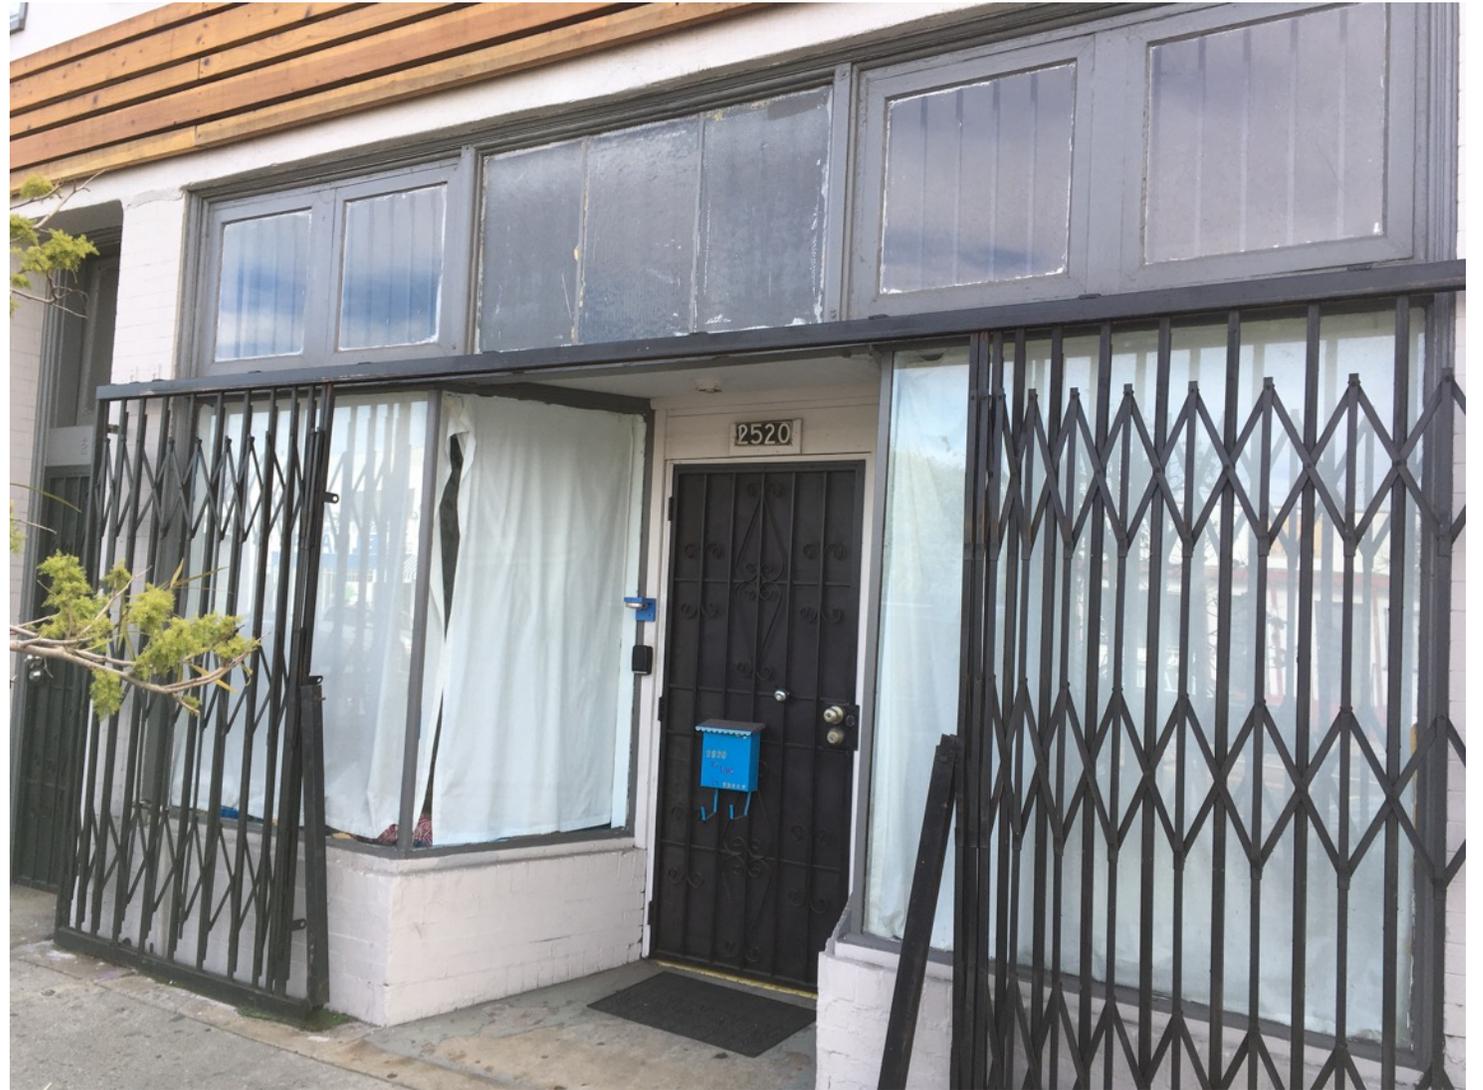
2520 Jefferson Blvd. Still has the Vboard above doorway and original light fixture.

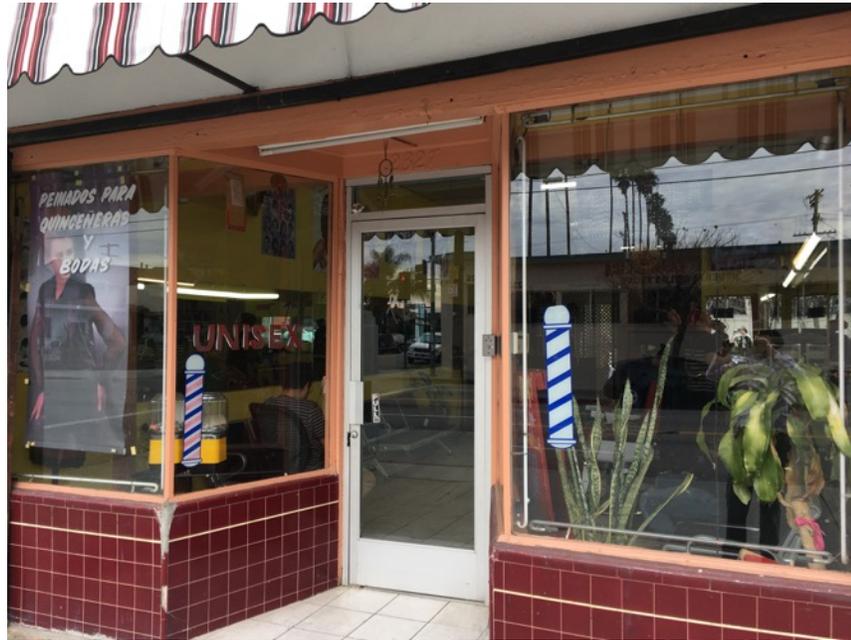
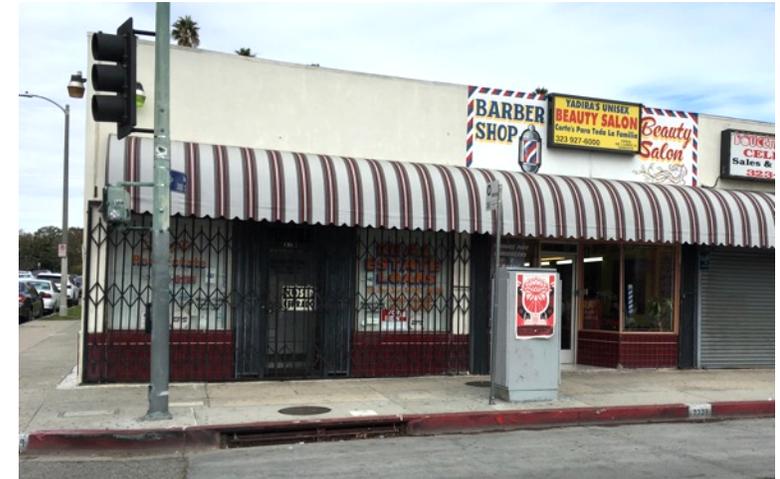
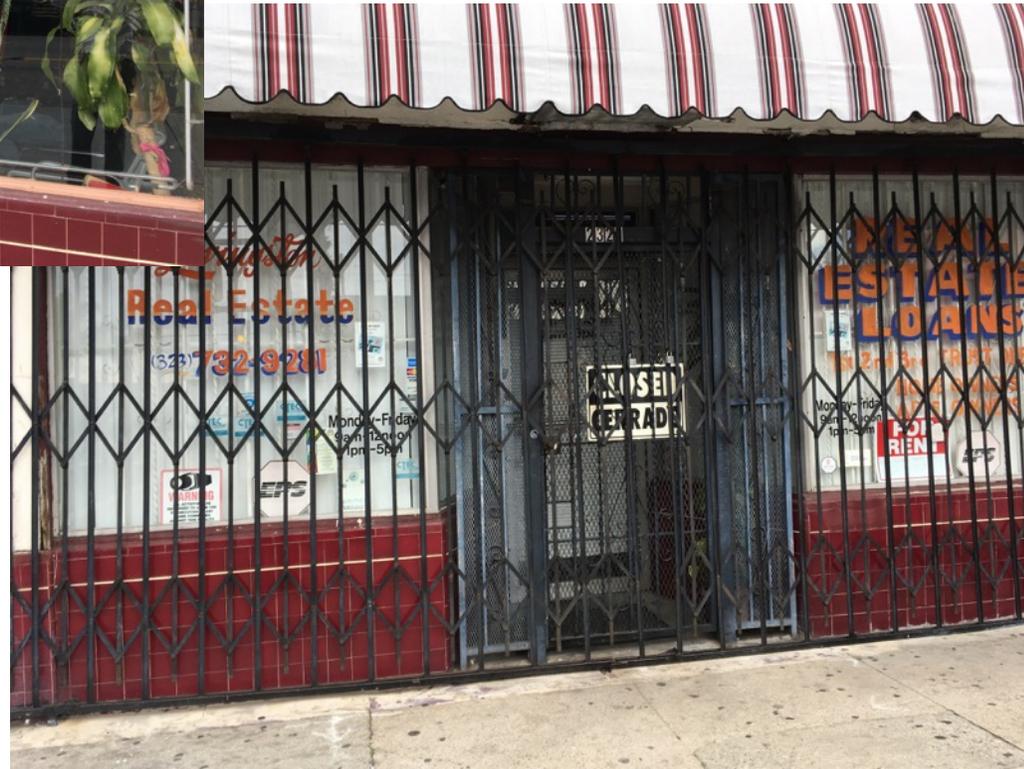
This is an example of a single story commercial building. 2325 Jefferson with tile bulkhead.

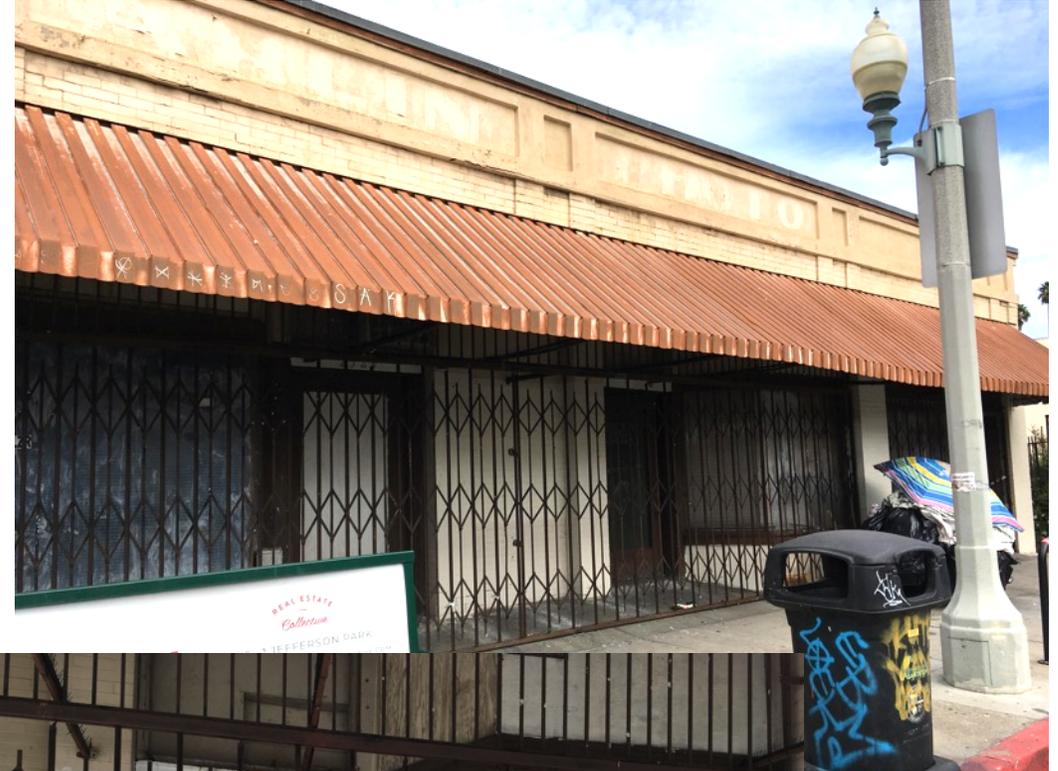
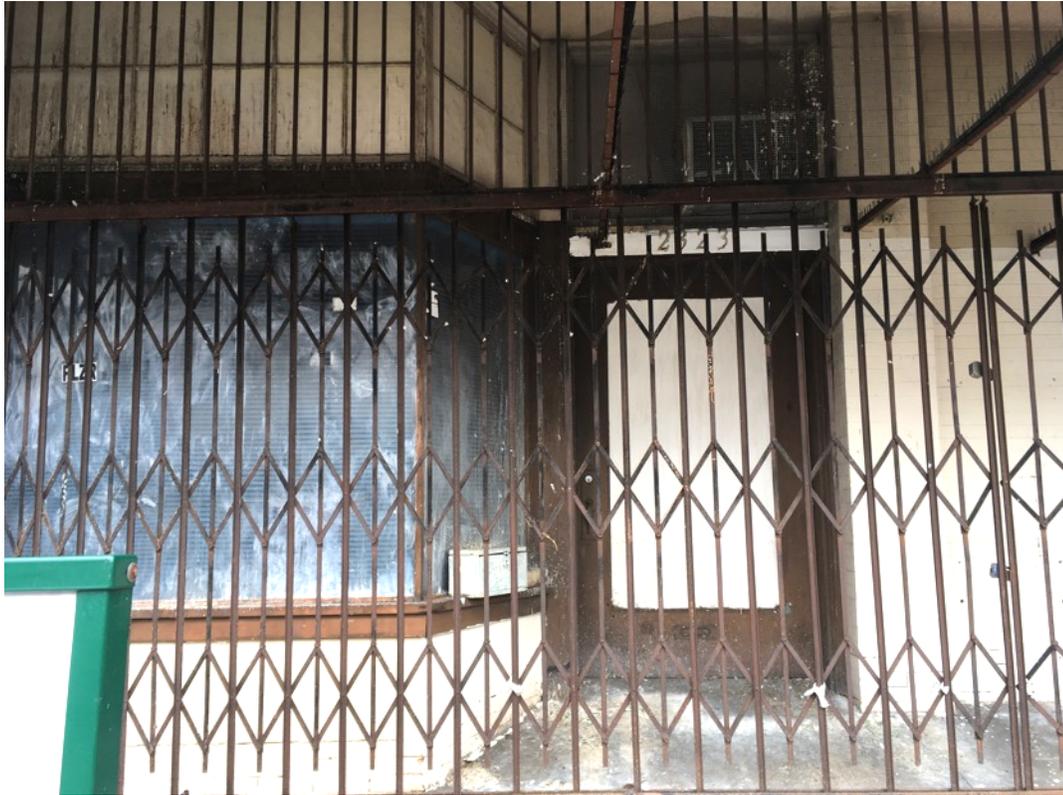
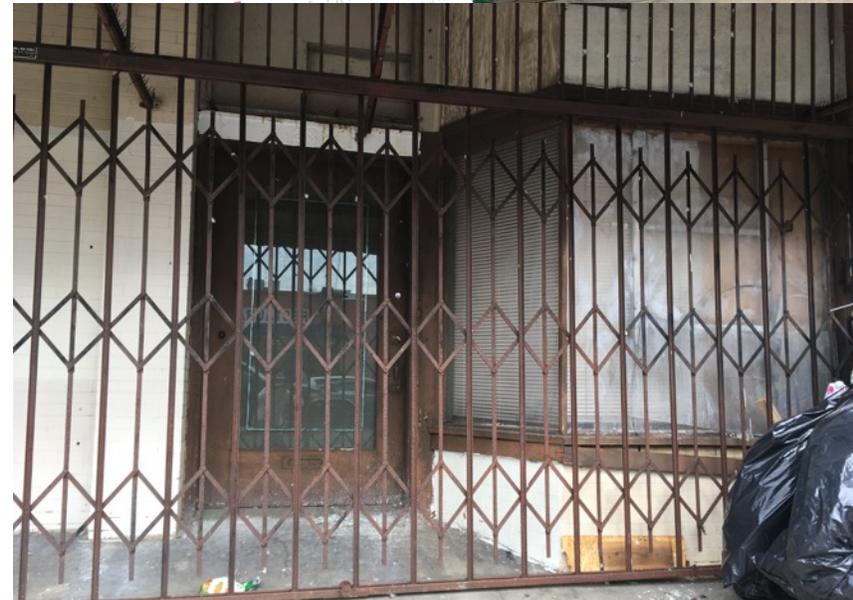
Another single story commercial building, 2319 Jefferson with original doors (glass with wood frame) and intact bays. Same arrangement: clerestory windows (boarded up), inset doorways, brick bulkhead, single pane display windows.

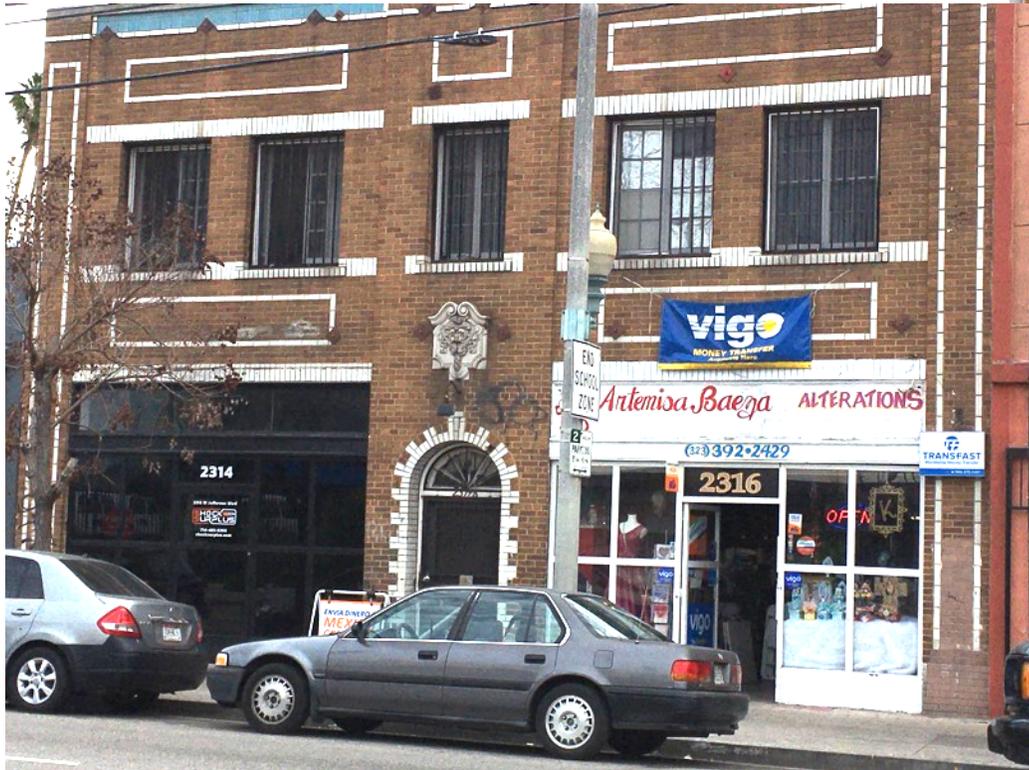
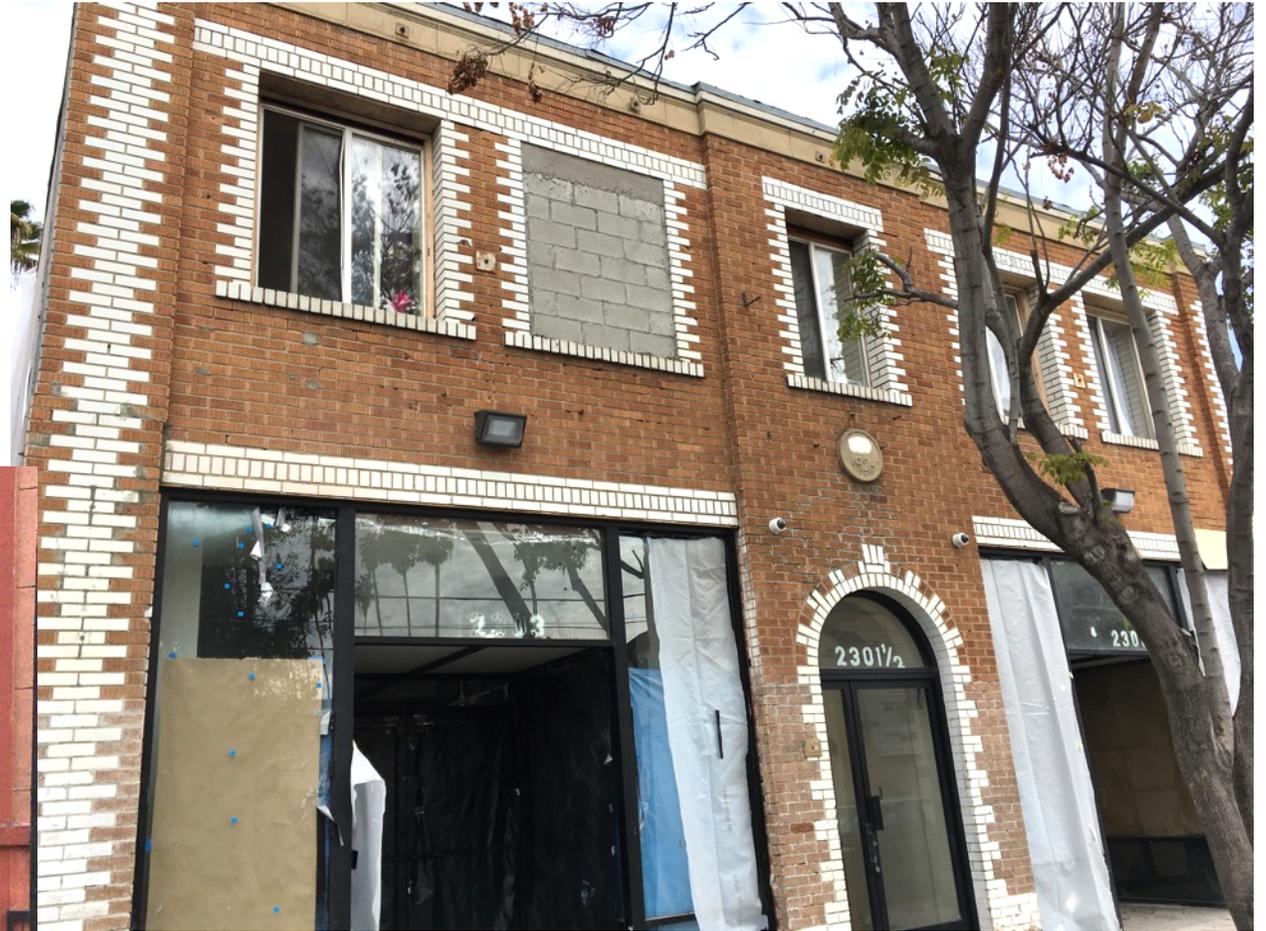
As it has happened on Jefferson Blvd., these two handsome buildings have lost their original store fronts. 2314 and 2301 Jefferson. But they would have had clerestory windows, inset central doorways, bulkheads, and large single pane display windows.

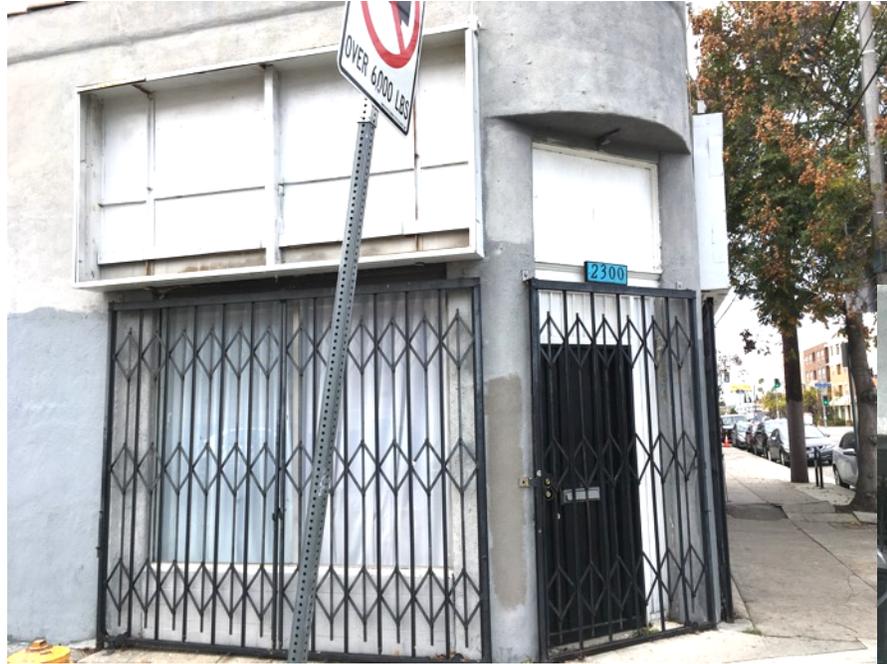
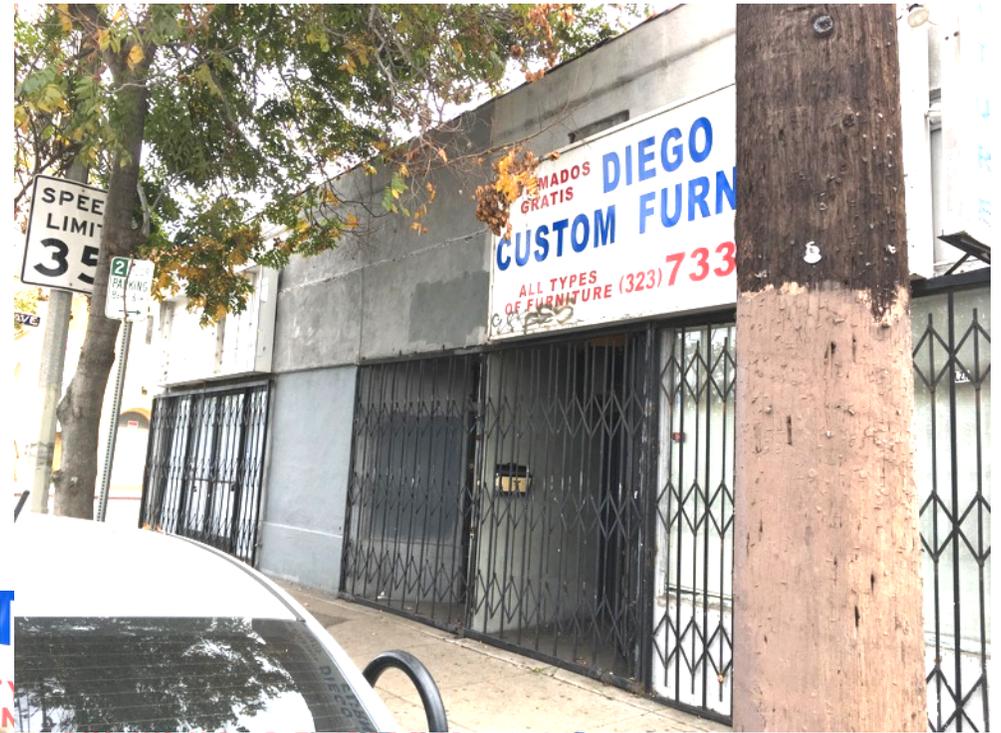
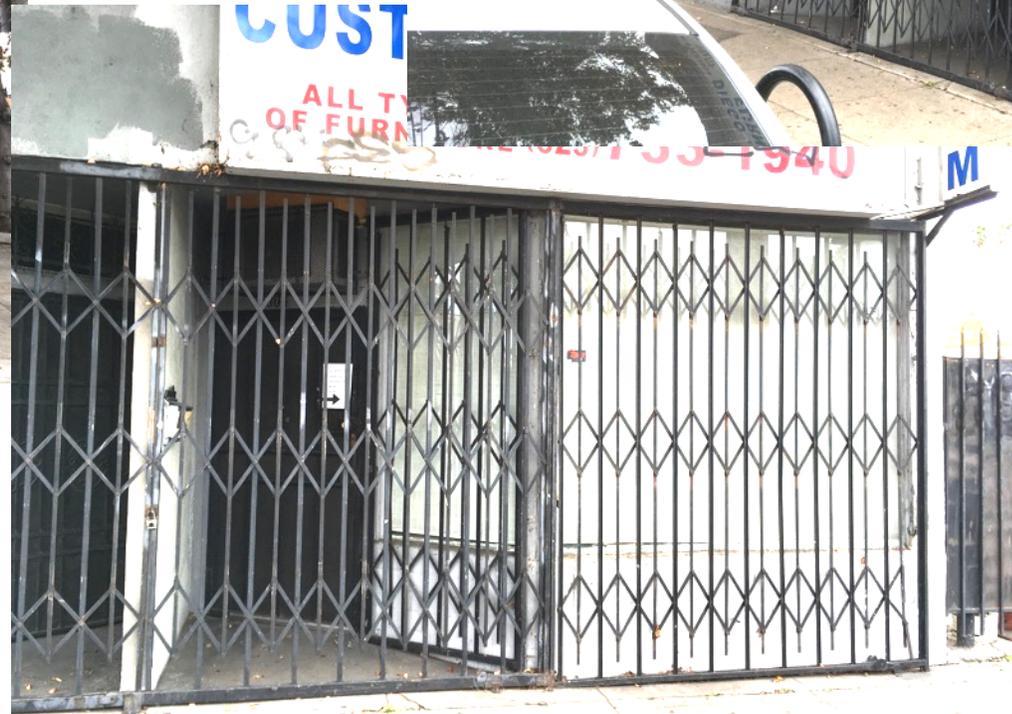
Another single story commercial building with a nice corner entrance. 2300 Jefferson from 1921. Two store fronts in a single bay. The large pane window for the second store front has been walled in.

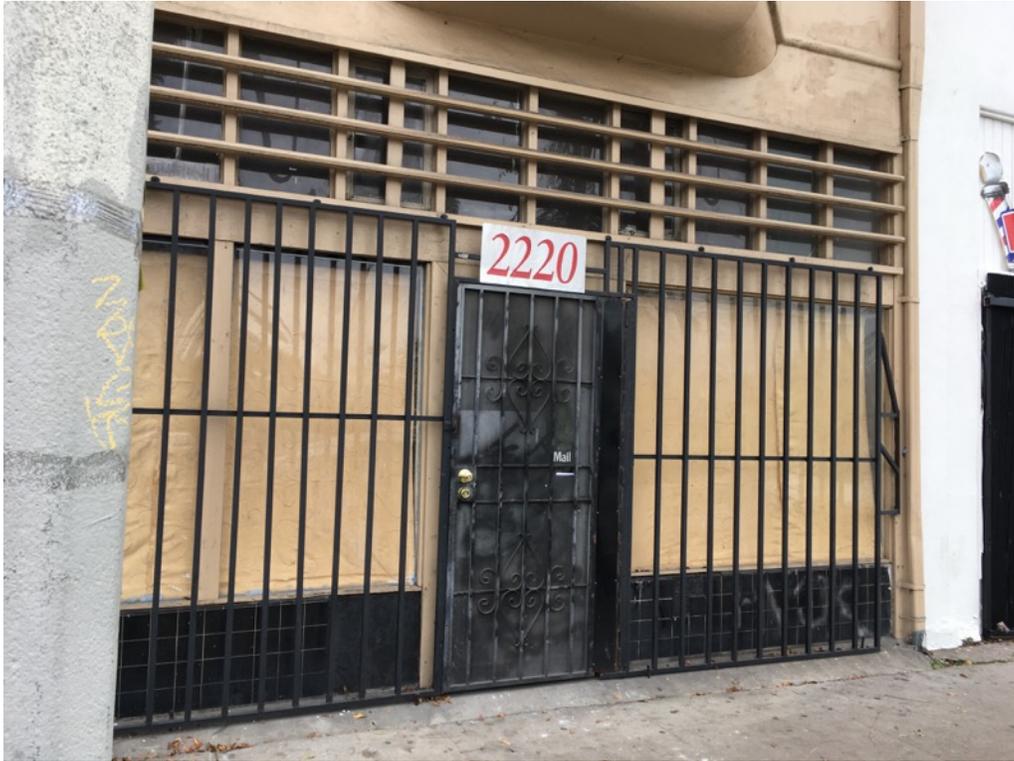
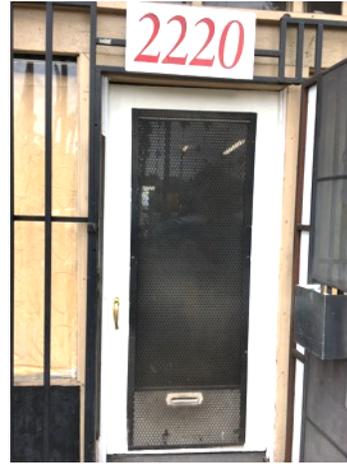
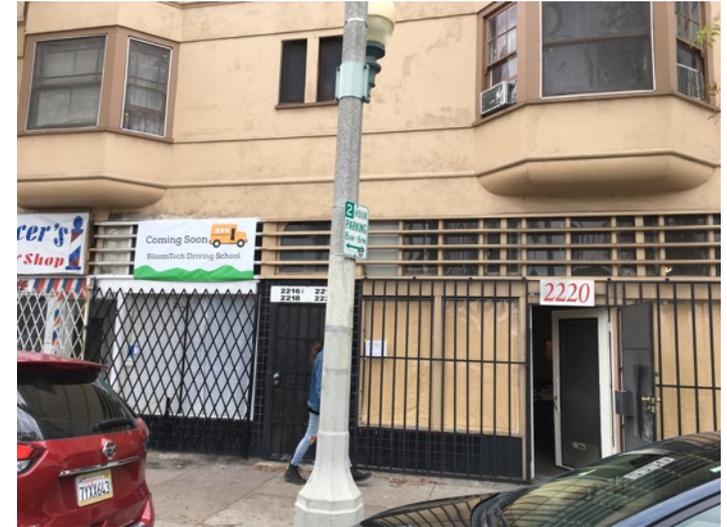
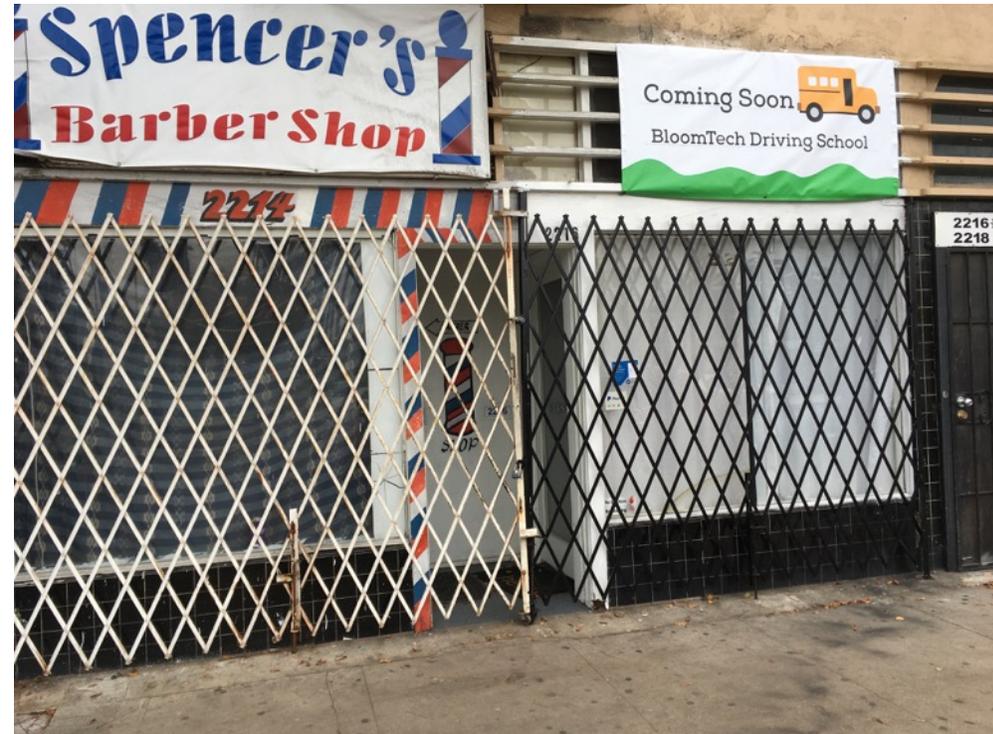
2216 Jefferson. Two story commercial.
Original central door. The original
doors on commercial buildings were
glass with a wood frame. Black tile on
the bulkhead. The doorway was
probably inset – as it is in the second
bay.

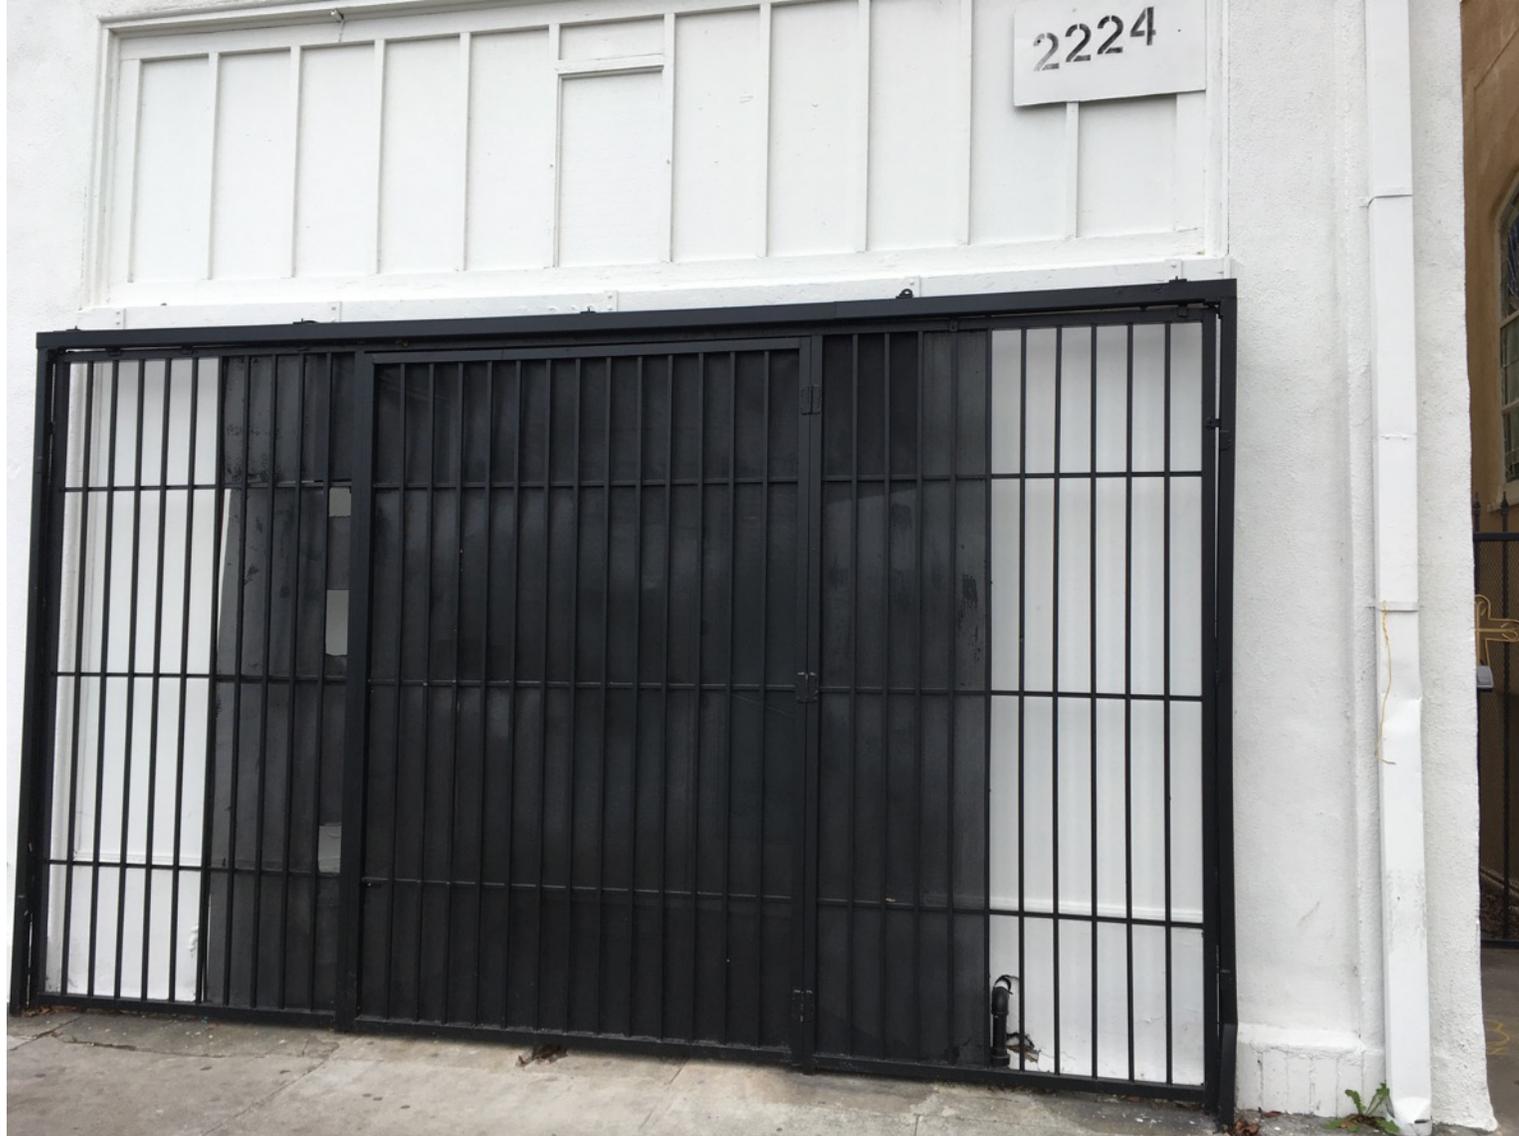
2222
Jefferson.
Walled up
storefront
windows –
but nice
clerestory
with multiple
lights.

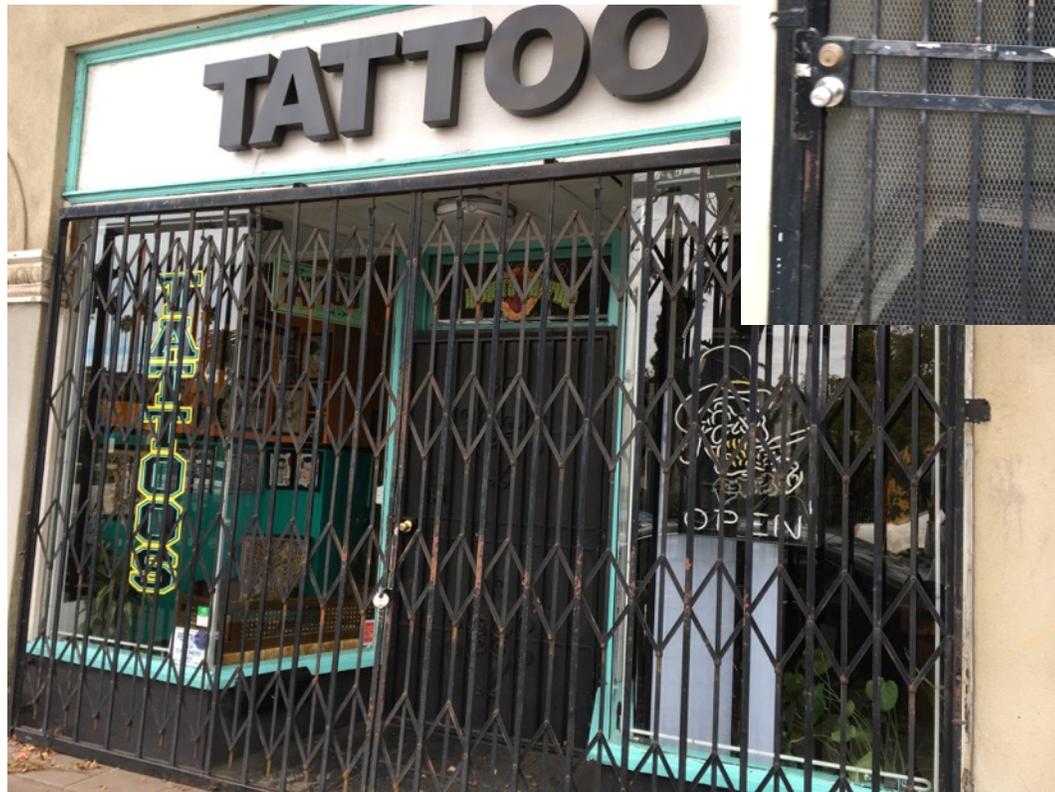
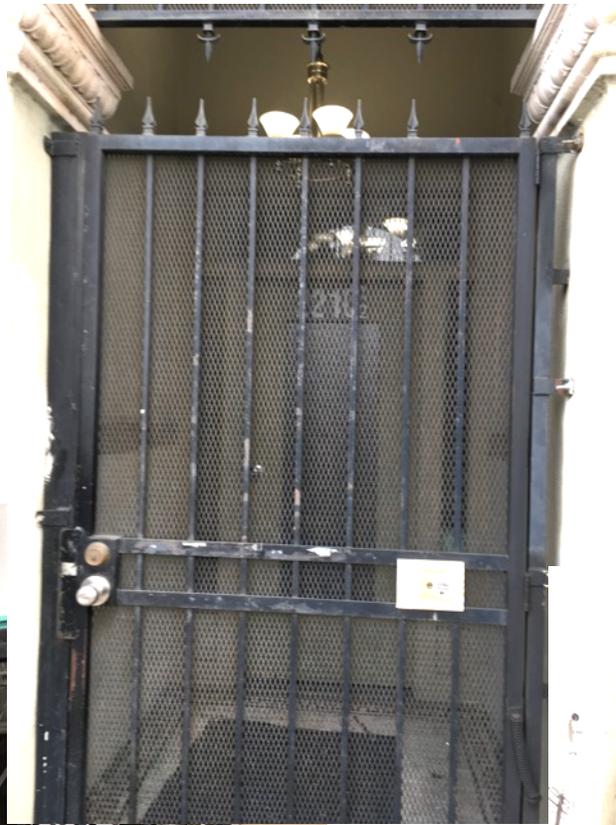
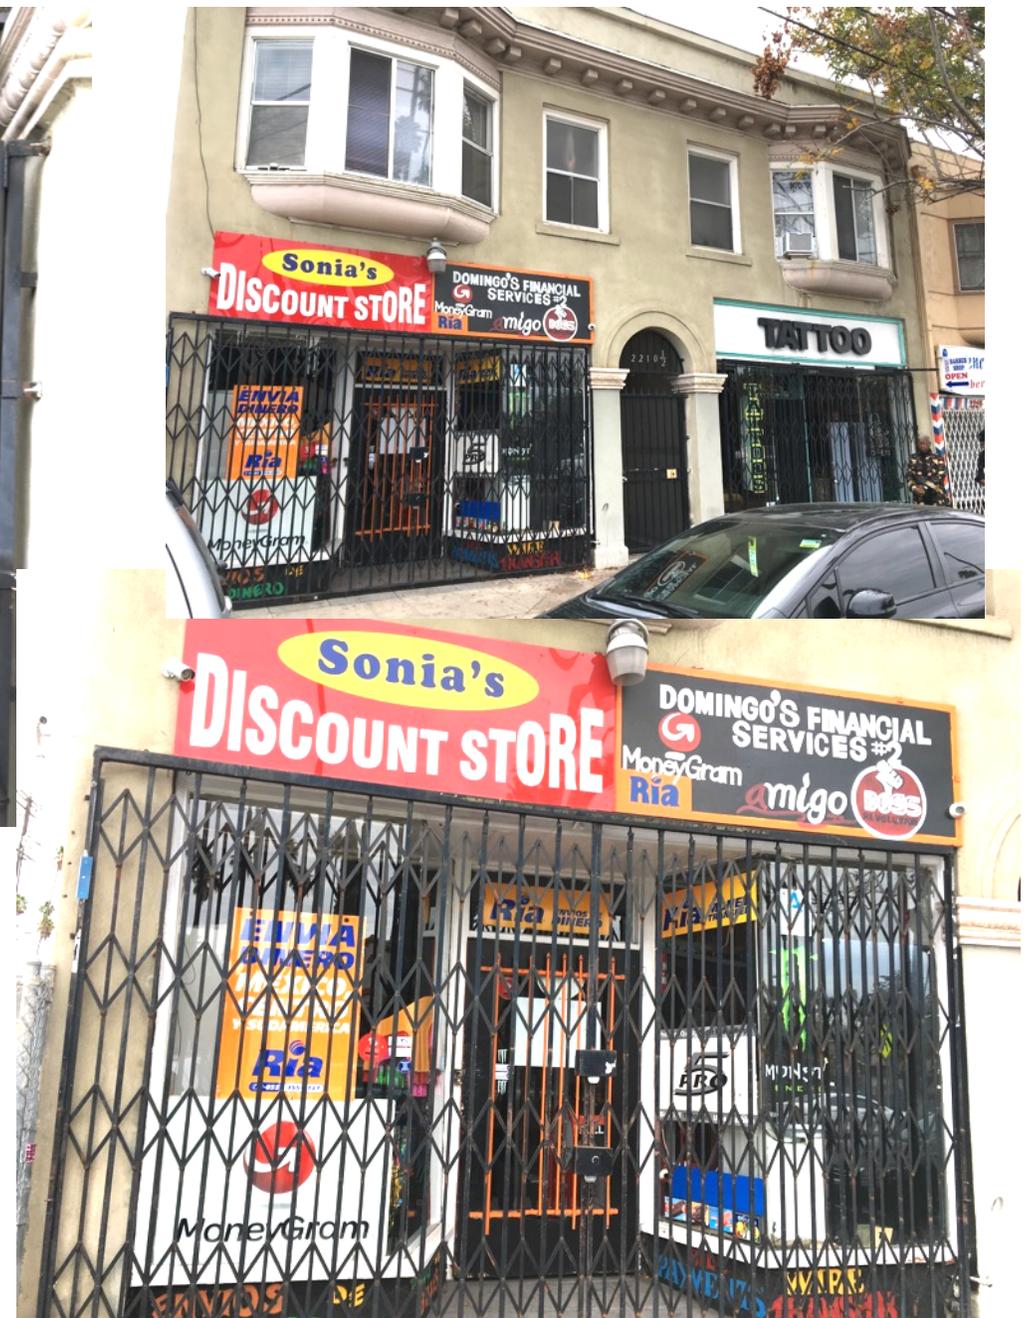
2210 Jefferson. You can make out the original glass/wood frame central door. The clerestory windows would have been where the signs are for the shops (Tattoo).

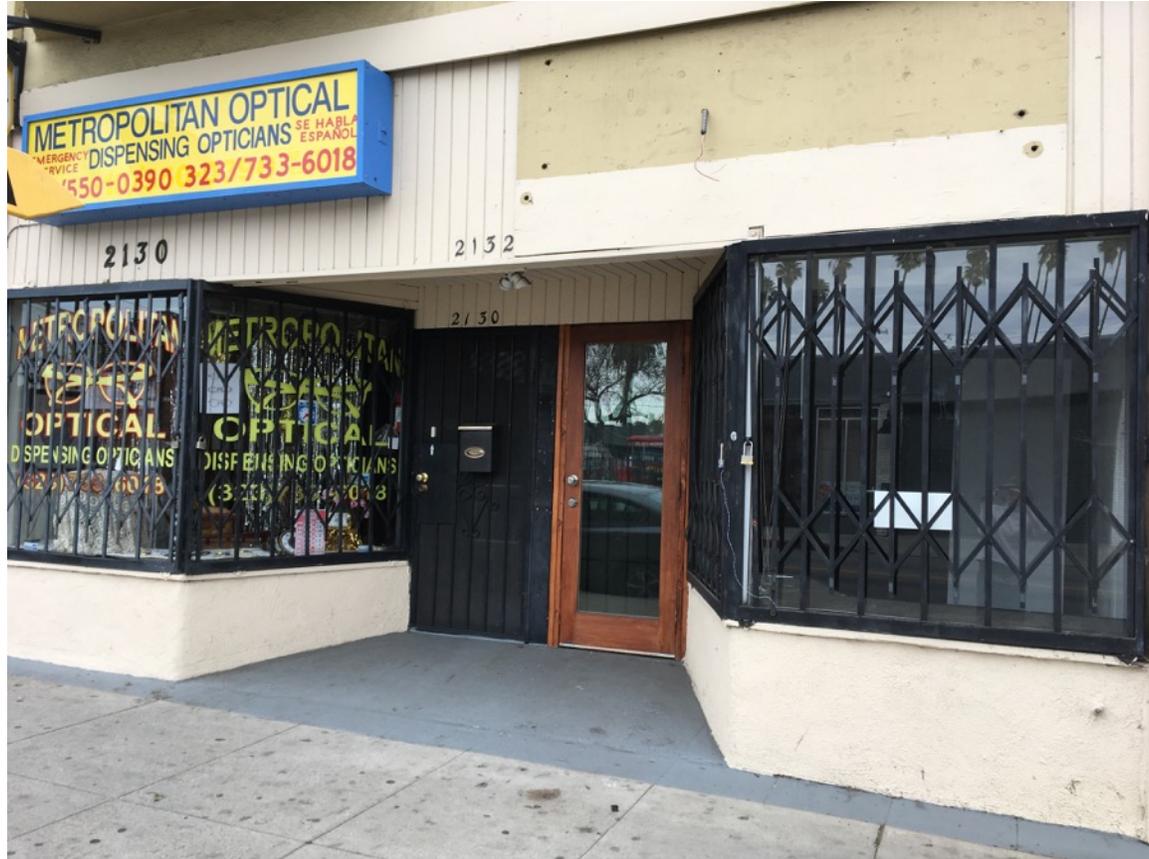
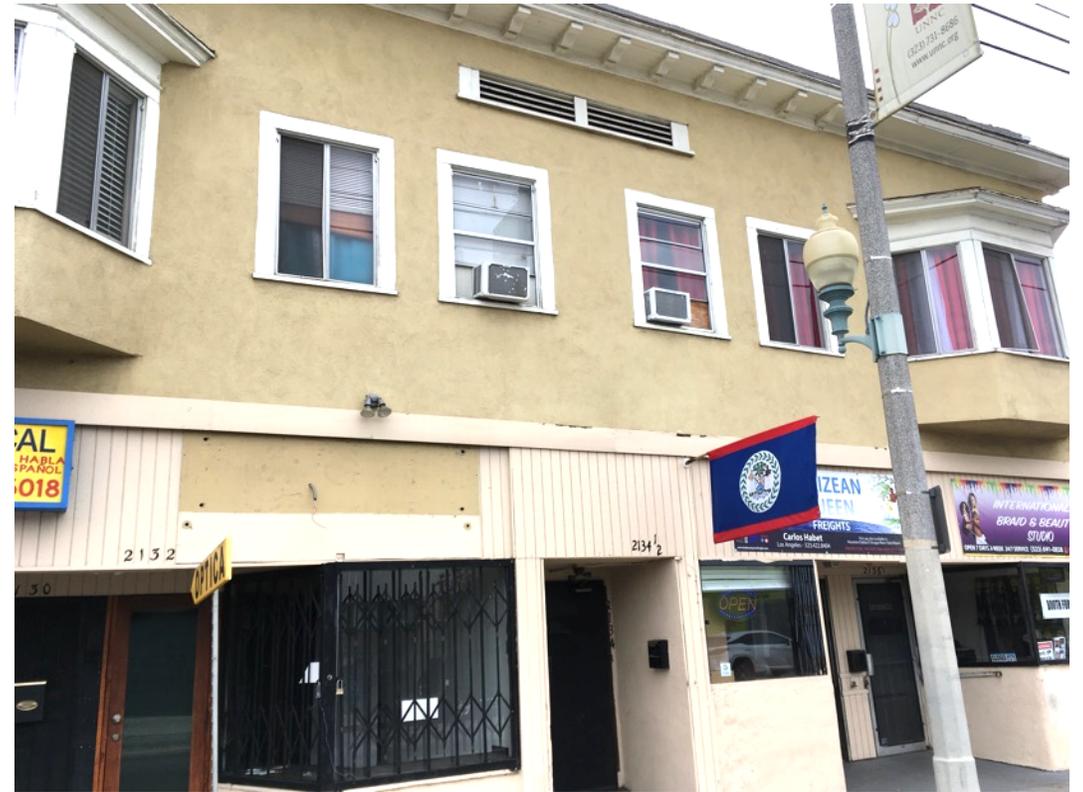
2130 Jefferson two stores in each bay.
Clerestory windows have been covered
over.
