Jefferson Park HPOZ
COMMERCIAL STORE FRONTS

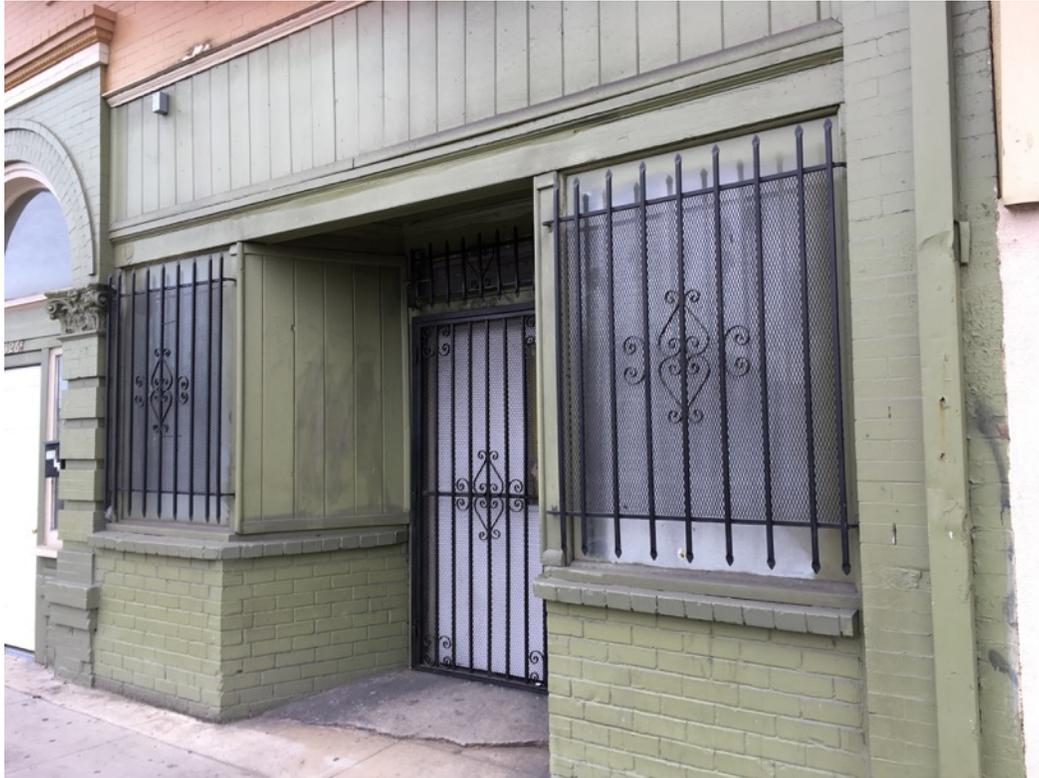
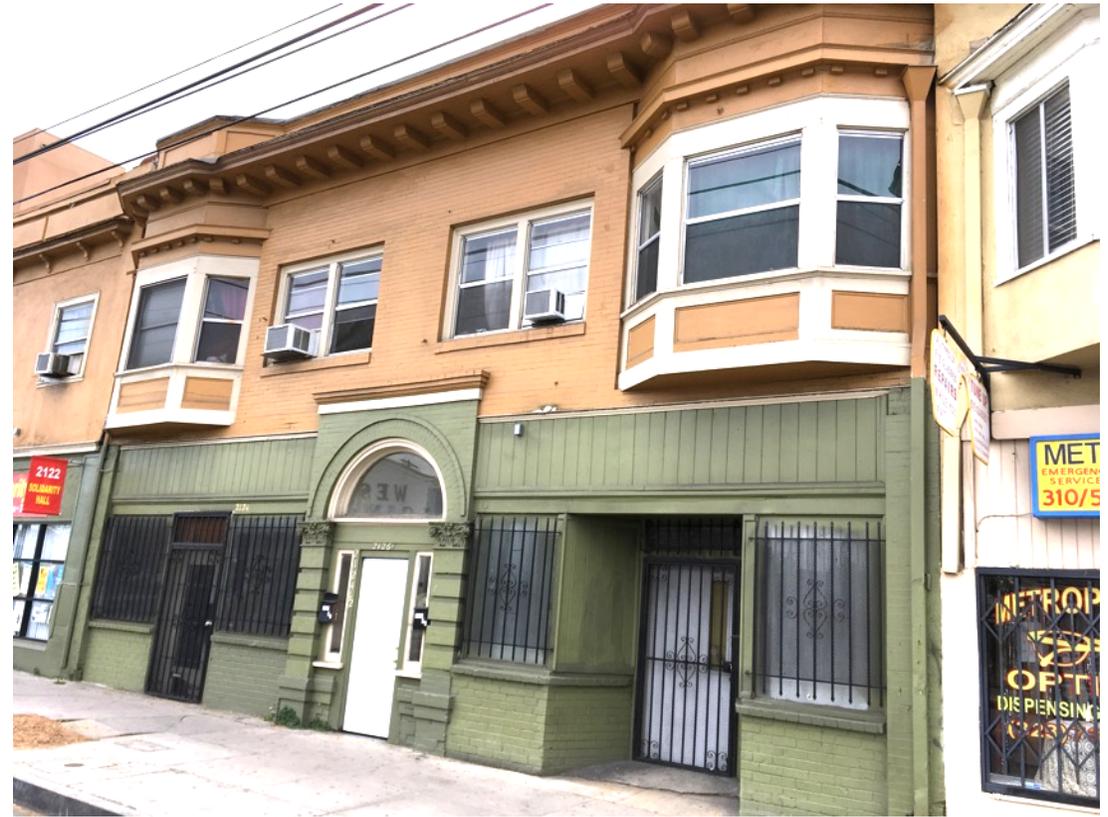
2126 Jefferson. Clerestory and some panes have been boarded up. Brick bulkhead.

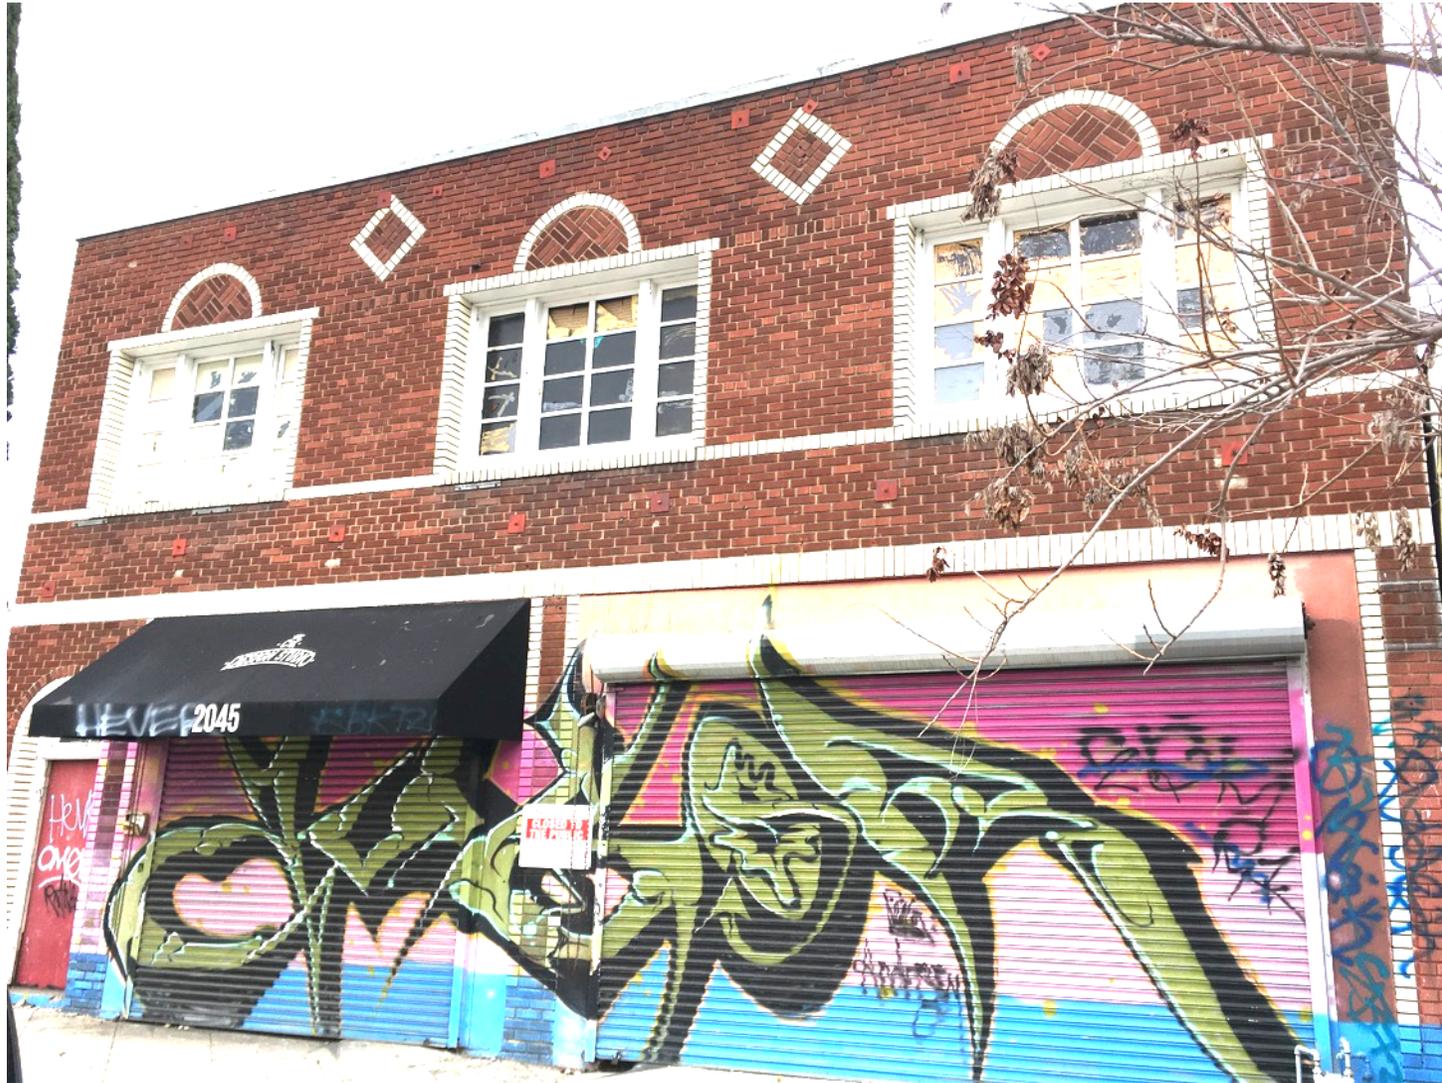
2043 Jefferson. A handsome two story commercial that has lost its store fronts. The bays are asymmetrical in size; one bay probably had a central inset doorway, and the other probably had an inset doorway to the side of the bay. It would have had a brick bulkhead, clerestory windows, and large single pane display windows. The doors would have been glass with wood frame.

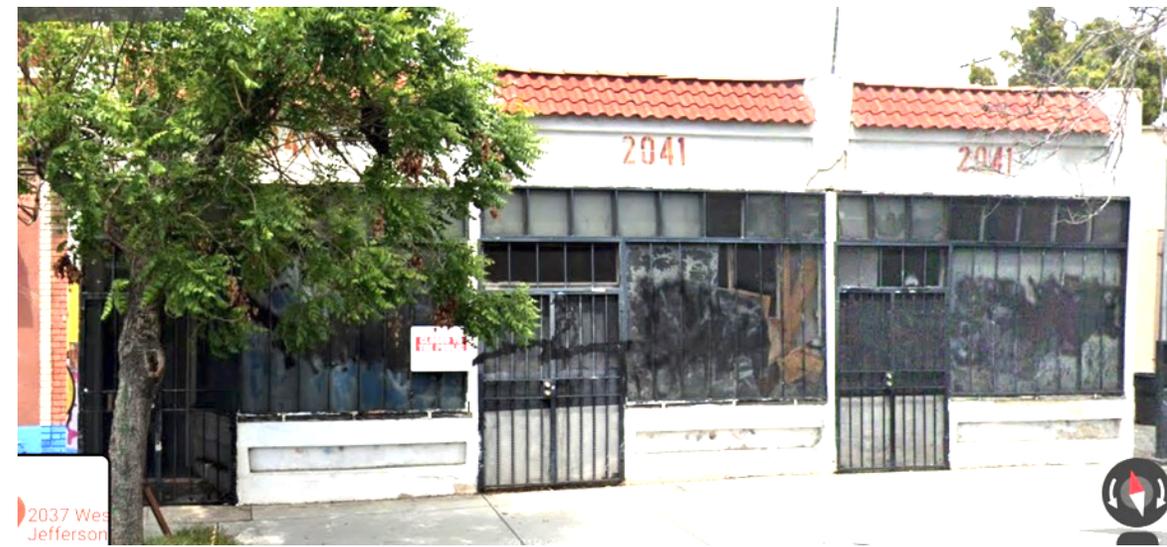
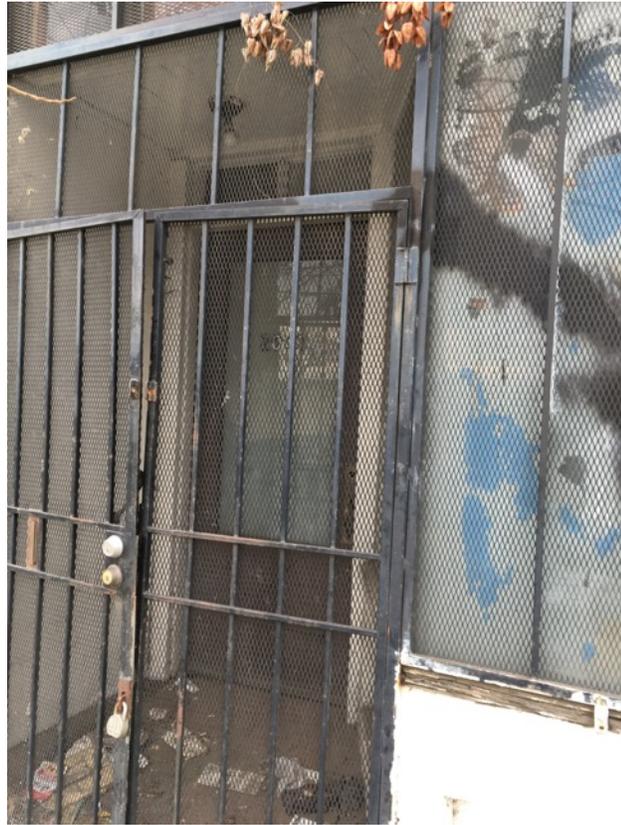
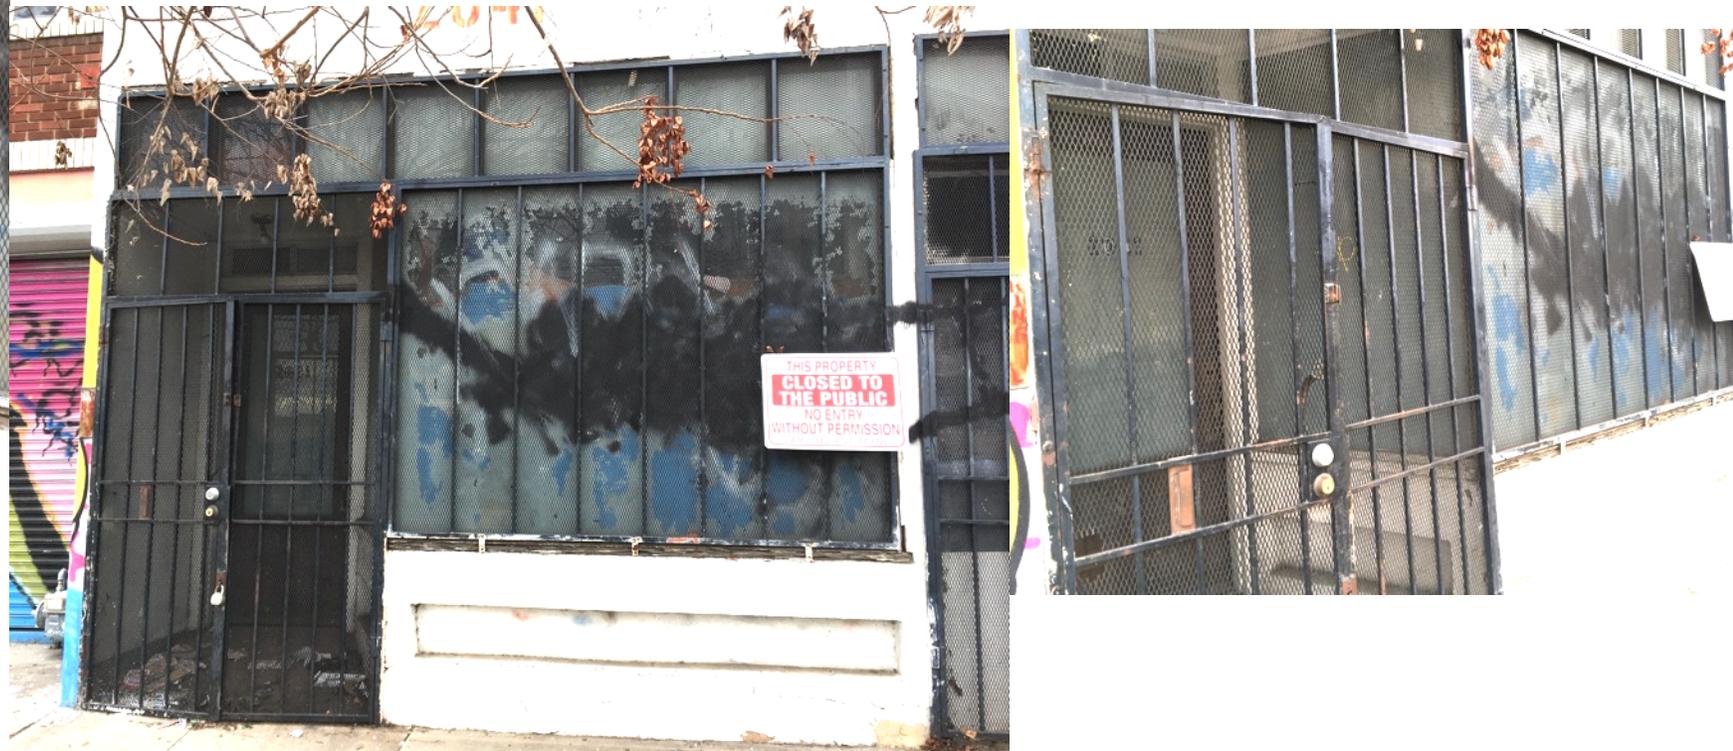
2037 Jefferson. A handsome single story commercial with one intact bay and remarkably preserved. The other two bays are missing the inset doorway. The intact bay still has the original door and light fixture. The clerestory windows have survived as well.
